## SEWER SCOPE INSPECTION

123 Sample Street, Demo City, ST 12345

6/12/2026 5:51AM

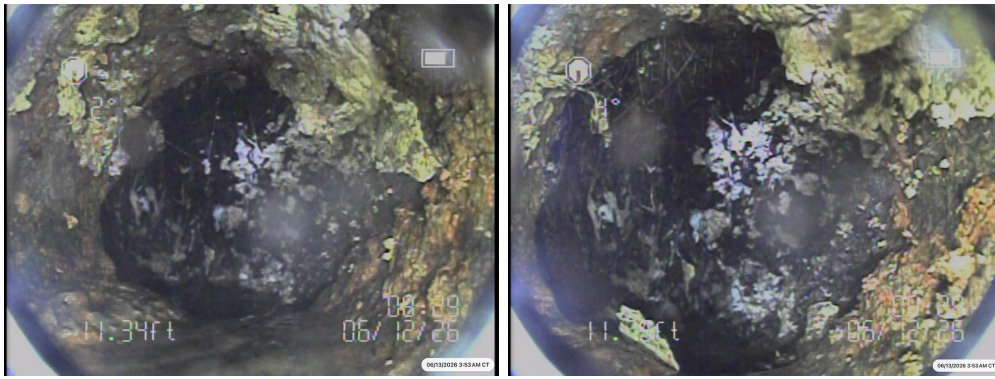
**Location:** Approx. 25 Feet From Basement Cleanout

#### 1.2.4 Sewer Line-Complete Blockage Observed

**! Serious Concern / Safety Hazard / Immediate Action Recommended**

A near-complete blockage was observed in the sewer line during the sewer scope inspection. The obstruction appeared consistent with significant root intrusion and was located approximately 25 feet from the basement cleanout. The blockage was severe enough to prevent further evaluation of the sewer line beyond the affected area. Root intrusion can restrict wastewater flow and contribute to backups, pipe deterioration, and recurring drainage issues. Remediation is recommended to clear the blockage and evaluate the condition of the pipe after access has been restored. Failure to address this condition may result in sewage backups, continued drainage problems, or additional damage to the sewer system.

**Service:** Plumbing Contractor

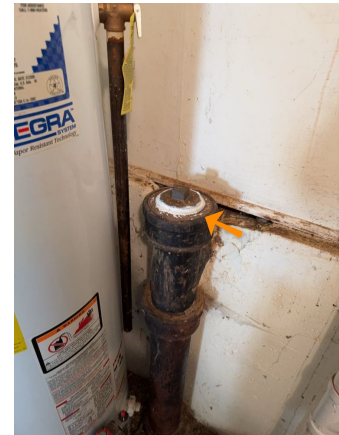
**Location:** Basement

### 1.2.5 Clean-Out(s) Threads- Damaged, Deteriorated Or Cross-Threaded

Repair Recommended / Moderate Concern

One or more clean-out thread connections in the referenced area(s) were observed to be damaged, deteriorated, or cross-threaded. This condition can prevent the cap from sealing properly and may make future access for drain cleaning or sewer inspection difficult. Repair or replacement of the affected clean-out components is recommended to restore proper function and serviceability and to help reduce the risk of leakage, sewer gas escape, or additional damage.

**Service:** Plumbing Contractor
