At Ease Inspections

## HOME INSPECTION REPORT

123 Sample Street, Demo City, ST 12345

6/18/2026 5:21AM

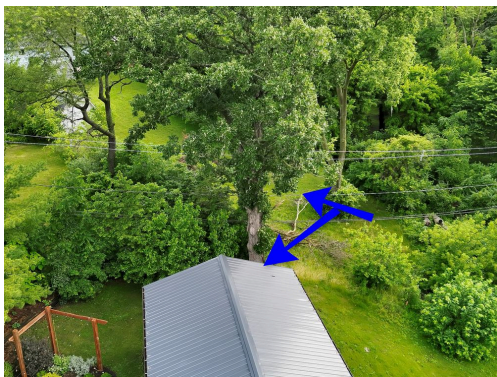
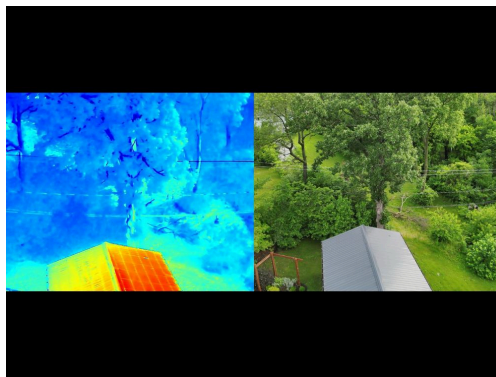
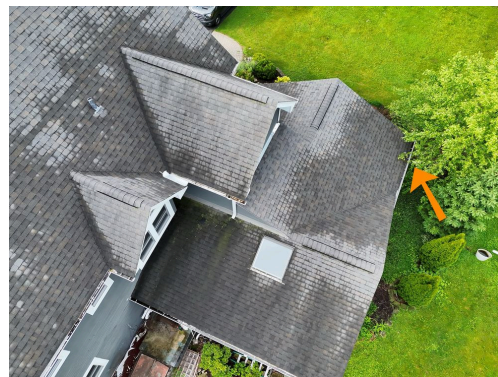
**Location:** Garage, Left Side Of Home

Tree limbs were observed contacting and overhanging the roof and gutter areas. Branches in contact with roofing materials can cause abrasion, accelerate wear, and damage shingles or other roof coverings. Overhanging limbs can also contribute to excessive debris accumulation within gutters, restrict proper drainage, and increase the potential for moisture-related deterioration and storm damage. The inspector recommends trimming the affected trees to provide adequate clearance from the roof and gutter system and to help reduce the likelihood of future damage.

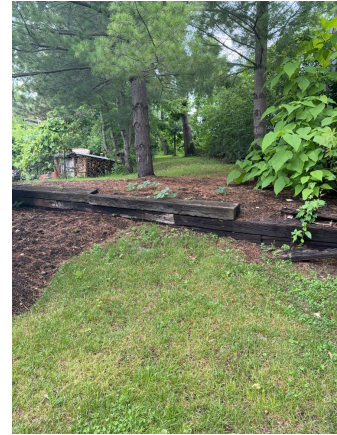
**Location:** Back Of Home

One or more retaining wall was observed to have signs of deterioration, including cracks, shifting, or material wear. Retaining walls are designed to support soil and prevent erosion, and deterioration can compromise their structural integrity over time. Contributing factors may include soil pressure, poor drainage, freeze-thaw cycles, or aging materials. The inspector recommends evaluating the retaining wall and considering repairs or reinforcements as needed to maintain stability. Failure to address this issue may result in further structural weakening, soil displacement, or potential failure of the retaining wall.

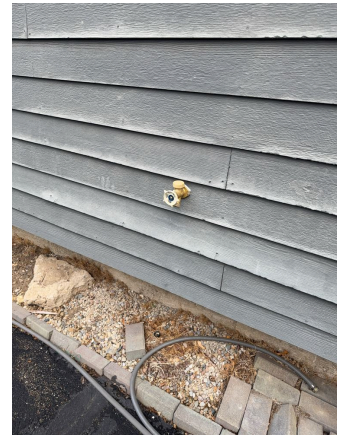
**Location:** Right Side Of Home

One or more water spigot(s) in the referenced area(s) were observed to be inoperable, which may restrict outdoor water access or use. This condition can stem from a closed shut off valve on the interior of the home, seized valves, corrosion within the fixture(s), or an upstream shut-off, preventing water flow when operated; there may have been a shut-off stopping the water flow that the inspector was unable to locate. The inspector recommends evaluating the spigot(s) and their supply line(s), including a search for any hidden shut-off valves, and making necessary adjustments, such as repairing the valve(s) or replacing the unit(s), to restore proper function. If this issue isn't addressed, it may limit outdoor water availability, impede routine maintenance, or conceal potential plumbing issues over time.

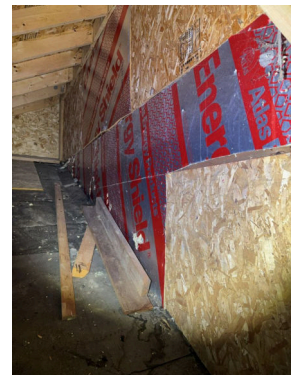
**Location:** Right Side Of Home, Porch

Moderate deterioration was observed in portions of the wood siding, and one or more overhangs, bay windows, bump-outs, or exterior wall areas lacked proper sealing, paint protection, and/or visible weather-resistive barrier materials. These conditions leave exterior components more vulnerable to moisture intrusion, rot, insect activity, air leakage, and concealed deterioration within wall assemblies. Continued exposure to weather can accelerate damage and may result in more extensive repairs if not addressed. The inspector recommends repairing or replacing deteriorated siding, properly sealing and painting exposed materials, and correcting areas where the weather-resistive barrier is missing or compromised to help restore the exterior envelope and protect the structure from moisture intrusion.

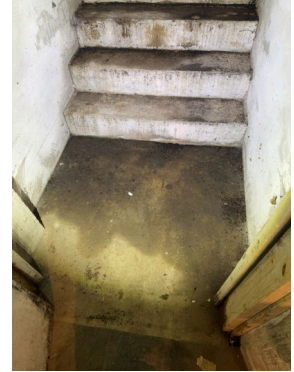
**Location:** Back Doors, Basement

One or more exterior doors exhibited gaps around the frame and/or threshold, and one or more doorways were installed below grade without adequate drainage provisions. These conditions can allow drafts, moisture intrusion, and pest entry while also increasing the likelihood of water accumulation at the doorway. Continued exposure to moisture may result in deterioration of door components, interior finishes, and adjacent building materials. The inspector recommends sealing and adjusting the affected doors as needed to restore a weather-tight seal and improving drainage at below-grade door locations to help direct water away from the structure and reduce the potential for leakage.

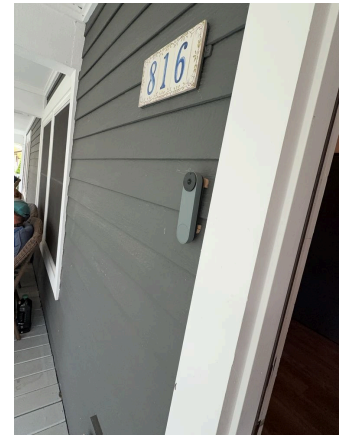
**Location:** Front Of Home

One or more doorbell(s) in the referenced area(s) were observed to be not functional or inoperable, which may affect convenience and security. An inoperable doorbell can result from a variety of issues, such as a faulty button, disconnected wiring, or a malfunctioning chime, often due to age, wear, or electrical faults, preventing it from alerting occupants to visitors. The inspector recommends evaluating the affected doorbell(s) and making necessary adjustments, such as testing the button and chime, checking the wiring for continuity, or replacing the unit if needed, to restore functionality. If this issue isn't addressed, it may lead to missed visitors, reduced security awareness, or the need for an alternative notification system over time.

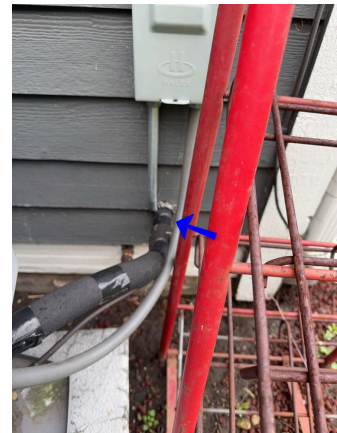
**Location:** All Sides

The exterior in the referenced area(s) was observed to have area(s) in need of sealant, which may compromise weather resistance and allow moisture intrusion. Areas lacking sealant, such as around windows, doors, or joints, can result from weathering, deterioration of existing sealant, or lack of maintenance over time, creating gaps that permit water to penetrate the exterior envelope. The inspector recommends evaluating the affected area(s) and making necessary adjustments, such as applying a high-quality exterior sealant to fill gaps and ensure a watertight barrier, to protect the structure and reduce air movement inside the home. If this issue isn't addressed, it may result in moisture intrusion, damage to the underlying materials, or mold growth over time.

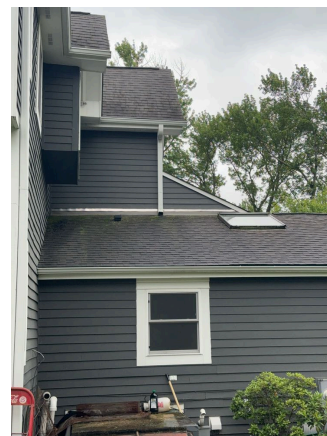
#### 4.2.1 Downspout(s)- Discharging Onto Lower Roof(s)

One or more downspout(s) in the referenced area(s) were observed to be discharging onto lower roof(s), this configuration can lead to concentrated water flow, increasing the risk of accelerated wear on roofing materials, water pooling, and potential leaks. Properly routed downspouts are essential for directing water away from the home's structure and preventing damage. Although not required, the inspector recommends extending or redirecting the downspouts to discharge water away from the roof and into a proper drainage area. Failure to address this issue may result in premature roof deterioration, water intrusion, and increased maintenance costs.

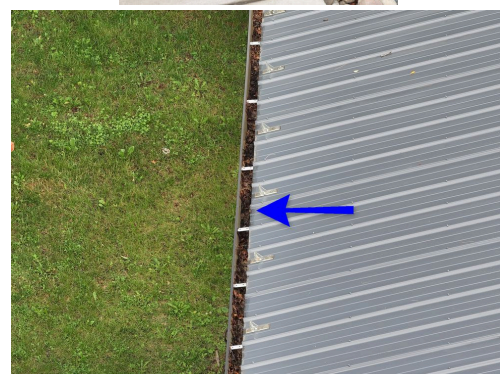
**Location:** All, Garage, House

The gutter system contained debris, and all downspouts discharged too close to the foundation. Clogged gutters can restrict proper drainage and cause water to overflow at the roof edge, while downspouts that terminate near the structure can allow water to accumulate around the foundation. These conditions may contribute to moisture intrusion, erosion, settlement, and premature deterioration of exterior building components. The inspector recommends cleaning the gutters and extending the affected downspouts to discharge water at least 4 to 6 feet away from the foundation to help improve drainage and reduce the potential for moisture-related concerns.

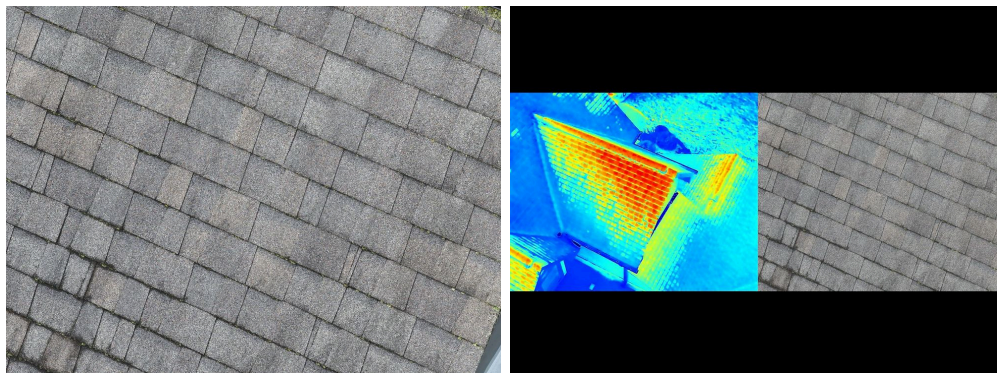
#### 4.3.2 Deterioration- Normal Deterioration- FYI

The asphalt shingles were observed to have moderate deterioration, including signs of wear such as granule loss, minor cracking, or curling. While the roof remains functional at this time, the observed deterioration may reduce its lifespan and increase the risk of moisture intrusion over time. The inspector recommends monitoring the condition of the shingles and planning for repairs or replacement as needed to maintain the roof's integrity. Failure to address ongoing deterioration may result in leaks, moisture intrusion, and potential damage to the underlying roof structure. Regular maintenance is advised to extend the roof's lifespan.

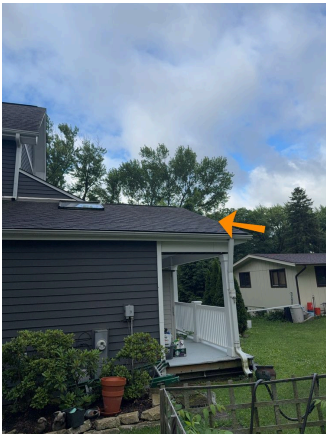
**Location:** Porch

The roof in the referenced area(s) was observed to have sheathing with sagging, soft, or low spot(s), which may compromise the roof’s structural integrity and weather resistance. Sagging, soft, or low spots in the sheathing can result from moisture damage, wood rot, or structural overloading over time, often due to past leaks, poor ventilation, or inadequate support, weakening the roof’s ability to support the roofing material. The inspector recommends evaluating the roof sheathing and making necessary adjustments, such as replacing the damaged or soft sections, addressing any moisture sources, and ensuring proper support, to restore structural stability. If this issue isn’t addressed, it may lead to further deterioration, potential roof leaks, or the need for more extensive repairs over time.

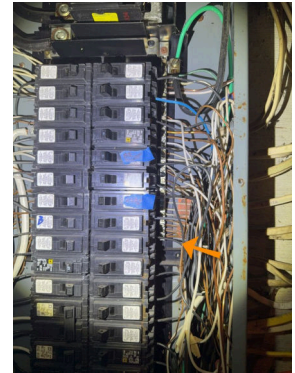
The electrical panel had missing or incomplete circuit labeling, minor corrosion, and grounding conductors that were double-tapped or terminated under shared lugs not intended for multiple conductors. In addition, evidence of moisture intrusion was observed within the panel enclosure, including presumed microbial growth and conditions suggesting moisture entry through an unsealed raceway or other opening. These conditions can reduce the reliability of the electrical system, contribute to loose connections, overheating, corrosion of electrical components, and create conditions conducive to continued deterioration if moisture intrusion persists. Failure to address these deficiencies may result in reduced electrical safety and reliability over time. The inspector recommends properly identifying and labeling all circuits, correcting the grounding conductor terminations, evaluating and addressing any corrosion or damaged components, sealing the raceway and other potential moisture entry points, and further evaluating the presumed microbial growth and moisture intrusion to help prevent future deterioration of the electrical equipment.

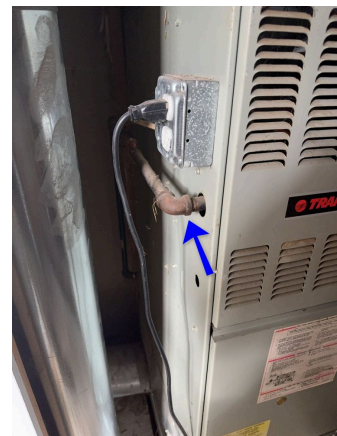
The furnace in the referenced area was observed without a sediment trap (also known as a drip leg) on the gas supply line. A sediment trap is designed to capture debris, moisture, and sediment from the gas line before it enters the furnace's control valve or burner assembly. This helps protect the internal components of the furnace and ensures safer, more efficient operation. The absence of a sediment trap may allow contaminants to enter the appliance, potentially leading to improper combustion, clogged components, or damage over time. The inspector recommends installing a properly configured sediment trap on the gas line. Failure to address this issue may result in reduced furnace performance, increased maintenance needs, or potential damage to the gas valve or burners.

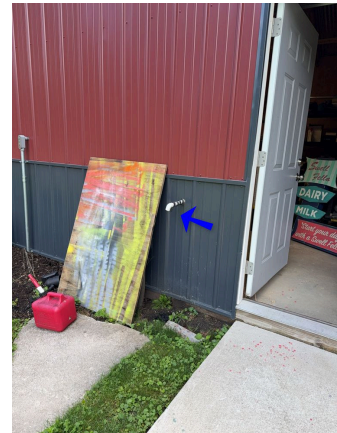
**Location:** Garage- Boiler

11.9.1 - Condensate Drain - Terminated Near Foundation (Location: Garage- Boiler)
-

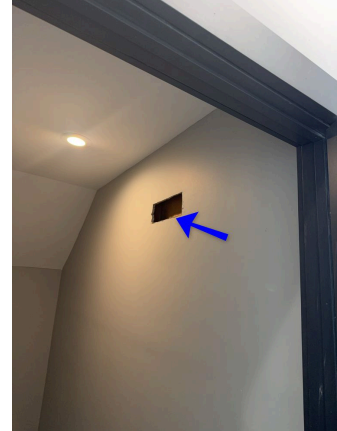
**Location:** 2nd Floor To 3rd Floor Hallway

11.12.3 - HVAC Supply Or Return Vent(s)- Missing Cover(s) (Location: 2nd Floor To 3rd Floor Hallway)
-

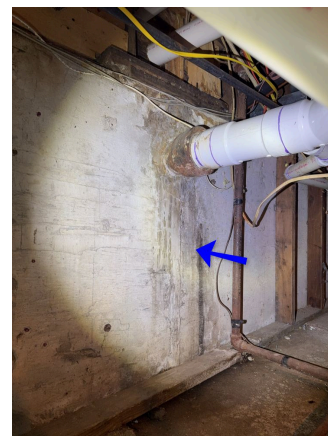
**Location:** Basement

12.4.2 - Foundation Cracks - Minor (Location: Basement)

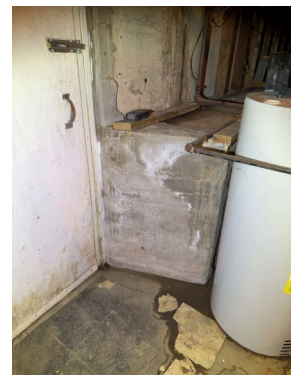
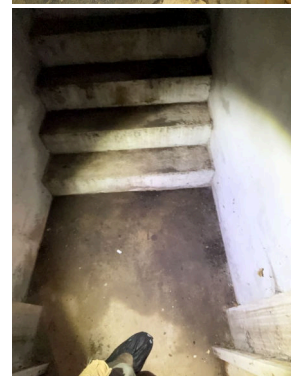
**Location:** Basement - Back Of Home

13.3.2 - Foundation Wall(s)- Active Moisture Intrusion (Location: Basement - Back Of Home)

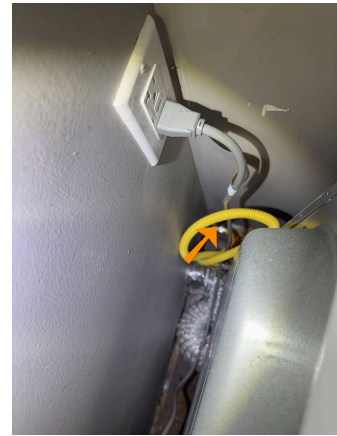
The gas dryer in the referenced area was observed without a visible or accessible gas shut-off valve. A shut-off valve is required near the appliance to allow for quick and safe disconnection in the event of maintenance, repair, or emergency. The absence of a shut-off valve may present a safety hazard and does not meet modern installation practices. The inspector recommends having a properly rated gas shut-off valve installed in an accessible location near the dryer. Failure to address this issue may result in delayed emergency response, increased risk during maintenance, and potential gas safety concerns.

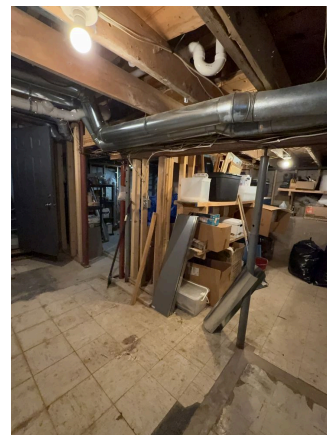
Supplemental support has been added in the framing structure in the referenced area(s). This appears to be a modification or reinforcement to the original floor support system. The visible support components were present at the time of inspection, and no significant defects were observed unless otherwise noted. The reason for the added support and any prior related repairs or alterations should be confirmed through available documentation if desired.

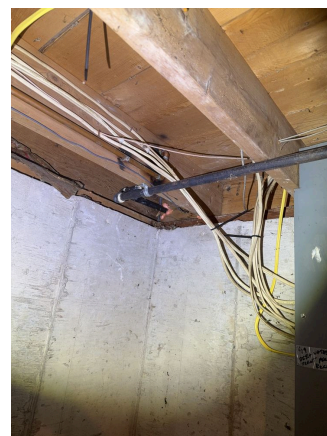
**Location:** Basement

19.6.1 - Exterior Walls- Above Grade- No Or Missing Insulation (Location: Basement)

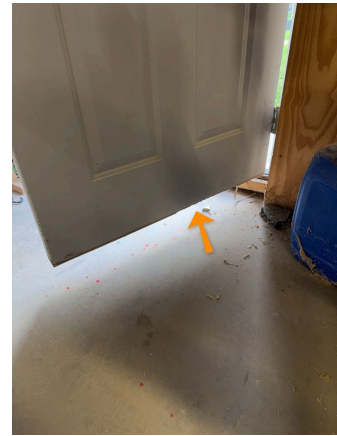
The door had damaged weatherstripping. Replacing affected portions is recommended to be performed by a qualified person.
