## HOME INSPECTION REPORT

123 Sample Street, Demo City, ST 12345  
6/20/2026 7:40AM

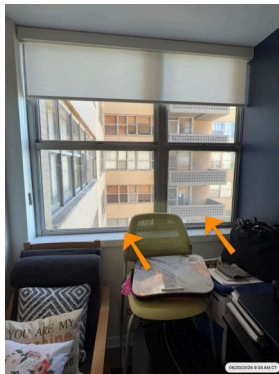
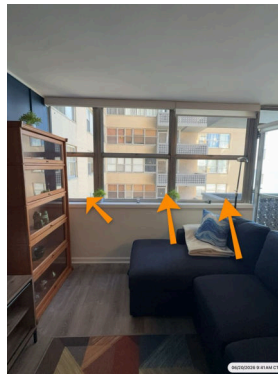
All windows were inoperable and would not open when tested. Operable windows are important for natural ventilation and overall occupant comfort. Windows may become stuck or inoperable due to paint buildup, warped frames, failed hardware, or settlement of the structure. The inspector recommends evaluating the inoperable window(s) and making repairs as needed to restore proper function. Failure to address this issue may limit ventilation, reduce emergency exit options, and compromise indoor air quality and comfort.

**Location:** All

**Service:** Window Repair Installation Contractor

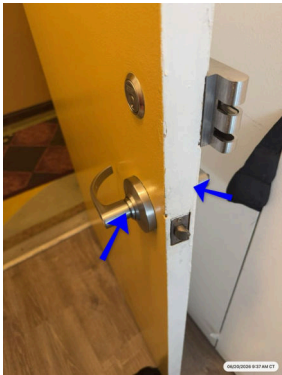
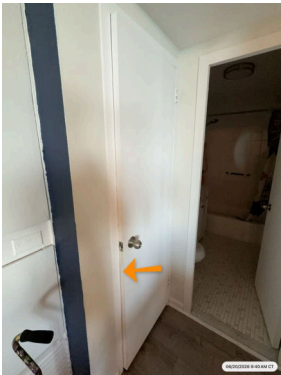
#### 3.3.1 Interior Door Hardware And Alignment Defects

One or more interior doors were binding at the jamb and did not close properly, and loose or improperly secured door hardware was observed. These conditions can affect normal operation, privacy, and the ability of the door to latch as intended. Continued use may result in additional wear to the door, frame, and hardware components. The inspector recommends adjusting the affected doors and jambs as needed and securing or repairing the loose hardware to restore proper operation and help prevent further deterioration.

**Location:** Front Door, Closet

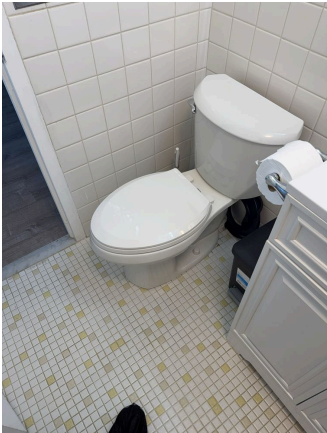
##### 4.3.1 Toilet(s)- Loose At Floor

One or more toilet(s) in the referenced area(s) were observed to be loose at the floor. A loose toilet may indicate deteriorated or improperly secured mounting hardware, a compromised wax ring seal, or movement in the underlying flooring. This condition can lead to leaks, moisture intrusion, and damage to subfloor materials. The inspector recommends evaluating the referenced toilet(s), securing them properly, and replacing the wax ring if needed. Failure to address this issue may result in water damage, unpleasant odors, and further loosening or instability of the toilet over time.

**Service:** Plumbing Contractor

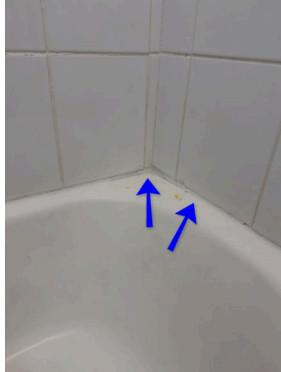
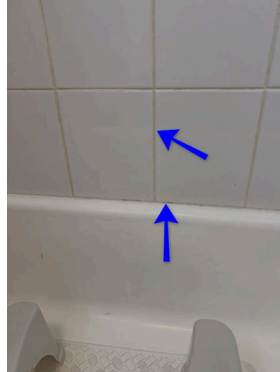
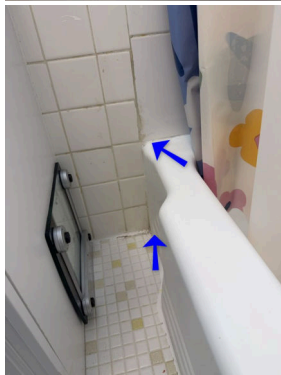
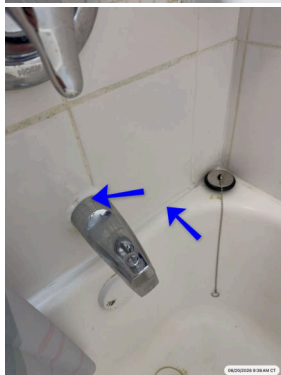
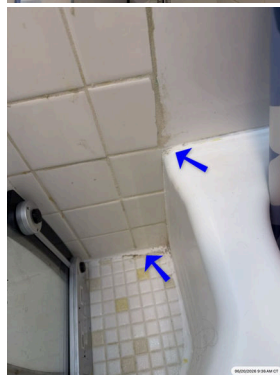
#### 4.4.1 Shower-Sealant And Fixture Deficiencies

The showers exhibited presumed microbial growth at caulk, grout, or sealant joints, excessive or improperly applied caulking, and loose fixture components at the wall. These conditions may indicate ongoing moisture exposure, prior repair attempts, or concealed gaps that can allow water to penetrate surrounding materials. Loose fixtures may also increase the potential for leakage behind finished surfaces. Failure to address these deficiencies may result in continued moisture intrusion, deterioration of adjacent building materials, and conditions conducive to additional presumed microbial growth. The inspector recommends evaluating the shower for moisture-related concerns, removing and replacing affected caulk and sealant, securing and properly sealing loose fixtures, and repairing any damaged materials as needed to restore a watertight enclosure.

**Service:** Plumbing Contractor

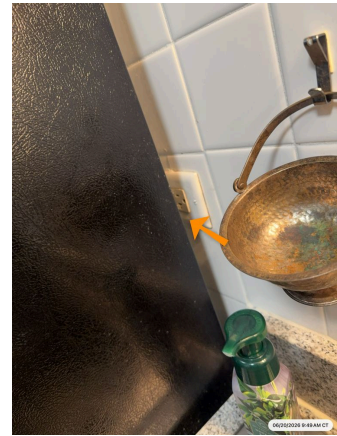
The refrigerator's ice maker and water dispenser could not be tested because the water supply appeared to be shut off, disconnected, or otherwise inoperable at the time of inspection. The refrigerator receptacle also appeared to be GFCI protected rather than on a dedicated non-GFCI circuit. While GFCI protection may be permitted in certain installations, nuisance tripping can interrupt power to the refrigerator without the homeowner's knowledge, potentially resulting in food spoilage or other issues.

The inspector recommends inquiring with the seller regarding the history and operation of the refrigerator water and ice system and verifying proper operation prior to use. The inspector also recommends consulting with an electrician regarding the refrigerator circuit configuration. Failure to address these concerns may result in undetected leaks, water damage, loss of appliance functionality, or unexpected power interruptions.

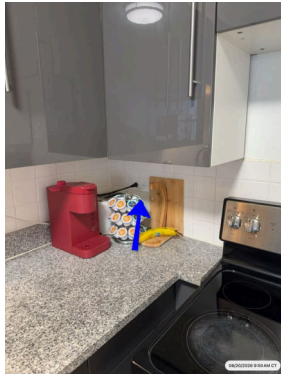
#### 6.2.1 Receptacle(s)-GFCI Protection Deficiencies

One or more receptacles lacked GFCI protection where such protection is commonly recommended, and one or more GFCI receptacles were inoperable or not supplying power at the time of inspection. GFCI protection helps reduce the risk of electrical shock in areas where moisture may be present. Inoperable GFCI devices may not provide the intended level of protection and can leave receptacles unusable. Failure to address these conditions may increase the risk of shock or injury and reduce the overall safety of the electrical system. The inspector recommends installing GFCI protection where needed and repairing or replacing the inoperable GFCI receptacles to restore proper operation and safety.

**Location:** Kitchen Countertop(s), Balcony

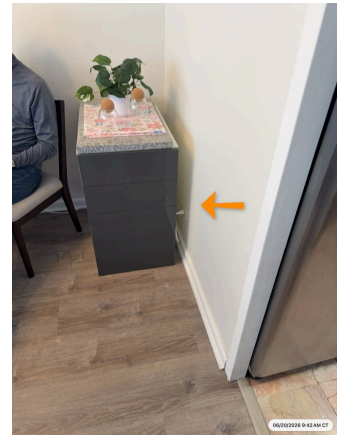
One or more receptacle(s) in the referenced area(s) were observed to have reversed polarity. This condition occurs when the hot and neutral wires are connected incorrectly, which can create a shock hazard and potentially damage electrical devices. Reversed polarity can also interfere with the proper operation of appliances and increase the risk of electrical failure or fire. The inspector recommends evaluating the referenced receptacle(s) and correcting the wiring as needed to restore proper polarity. Failure to address this issue may result in electrical hazards, potential damage to equipment, or increased risk of shock.

**Location:** Dining Room

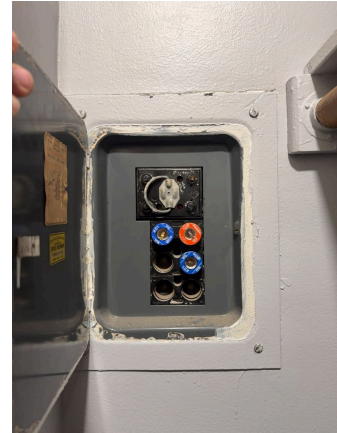
#### 6.4.1 Picture Of Service Panel Prior To Inspection: Picture Attached

*The home's electrical panel was found in the following condition (represented with the picture.)*

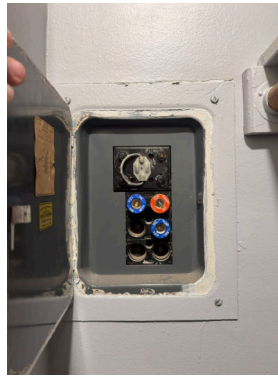
The electrical system included an older Edison fuse panel, and circuit identification was missing or incomplete at the panel. Inadequate labeling can make it difficult to safely identify and disconnect circuits during maintenance, troubleshooting, or emergency situations. Additionally, older fuse panels may present limitations related to safety, electrical capacity, serviceability, and insurability when compared to modern circuit breaker panels. Failure to address these conditions may result in operational difficulties and reduced electrical safety. The inspector recommends accurately mapping and labeling all circuits and consulting with a licensed electrician regarding the condition, capacity, and potential upgrade of the fuse panel to better meet modern electrical demands.

**Service:** Electrical Contractor

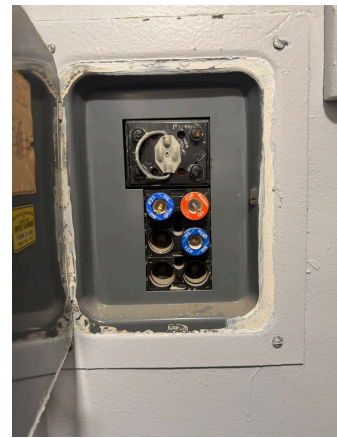
### 6.8.1 Picture Of Panel(s) After Inspector Completes Panel Inspection: Picture Attached

*The electrical panel was left in the following condition by the inspector. All circuit breakers returned to position inspector found them in.*

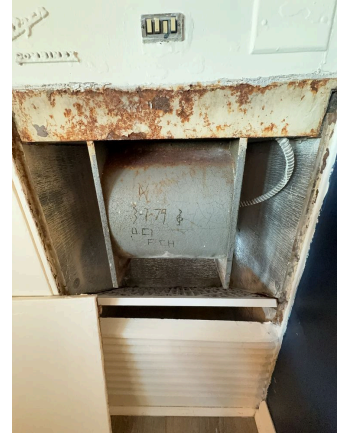
#### 7.4.3 About- 2 Pipe System

The fan coil unit is served by an **approximately 2-pipe system**, which typically uses one supply pipe and one return pipe to circulate heated or chilled water through the unit depending on the season. This type of system generally provides either heating or cooling at a given time rather than both simultaneously. It is a common design in multifamily and commercial-style buildings and was noted as part of the visible system configuration.

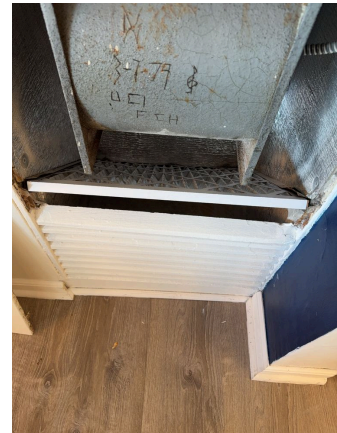
#### 7.4.4 FCU-General

One or more fan coil units exhibited visible corrosion and general deterioration, and a water sensor was not observed at the unit. Corrosion and age-related wear can reduce efficiency, contribute to leakage, and shorten the service life of HVAC equipment. Additionally, the absence of a water sensor may allow condensate leaks or overflows to go undetected, potentially resulting in moisture damage and conditions conducive to presumed microbial growth. The inspector recommends further evaluation of the affected unit(s), cleaning, repair, or replacement as needed, and installing a water sensor near the equipment to help provide early warning of leaks or condensate-related issues.

**Service:** Handyman Diy

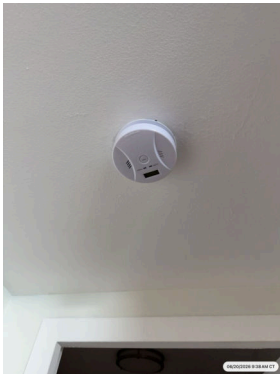
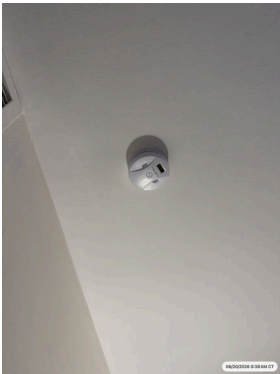
#### 13.1.1 Smoke Detector Locations- PICTURES: Hallway, Bedroom

Please follow the illustrations below on proper placement for carbon monoxide, smoke detectors and fire extinguishers. At Ease Inspections recommends replacing all smoke detectors in the home regardless of age with the recently mandated 10 year smoke/CO detectors. If you ever have any questions or concerns, please contact us immediately/CO detector placement is important and we want you to be safe!
