At Ease Inspections

## HOME INSPECTION REPORT

123 Sample Street, Demo City, ST 12345

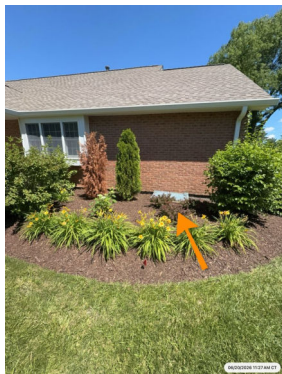
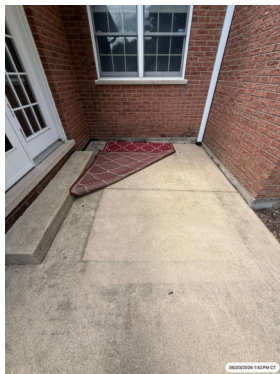
## 1.2.2 Grading & Drainage - Improper Slope Toward Structure

Negative or neutral grading was observed at one or more soil and hard-surfaced areas around the home, allowing water to drain toward or collect near the foundation. Improper drainage can contribute to moisture intrusion, foundation seepage, erosion, and premature deterioration of building materials. Failure to address these conditions may increase the likelihood of water-related issues within lower-level areas of the home. The inspector recommends regrading the affected soil and hard surfaces and implementing additional drainage improvements as needed to promote positive drainage away from the structure.

**Location:** Right Side Of Home, Back Of Home

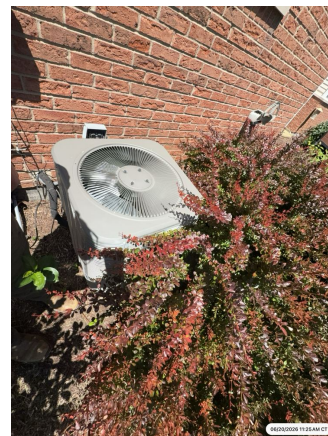
**Location:** Back Of Home

Vegetation was observed near, touching, or surrounding the AC condenser(s) in the referenced area(s). Plants, shrubs, or other obstructions in close proximity to the condenser can restrict airflow, reduce system efficiency, and cause the unit to overheat or operate under increased strain. This may lead to premature wear on components and reduced cooling performance. The inspector recommends trimming back vegetation and maintaining a clear area of at least 12–24 inches around all sides of the condenser to promote proper airflow and extend the life of the unit. Failure to address this issue may result in decreased system efficiency, higher energy costs, and potential mechanical failure.

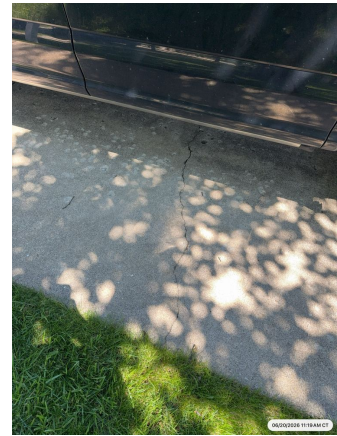
#### 1.4.1 Concrete- Common cracks < 1/4"

The concrete driveway was observed to have common cracks measuring less than 1/4" in width. Minor cracks in concrete are typical due to natural expansion, contraction, and settlement over time. These cracks are not structurally significant but may widen if exposed to moisture and freeze-thaw cycles. The inspector recommends routine monitoring and sealing the cracks as needed to prevent further deterioration. Failure to maintain the cracks may result in moisture infiltration, potential widening of the cracks, and premature wear of the driveway surface.

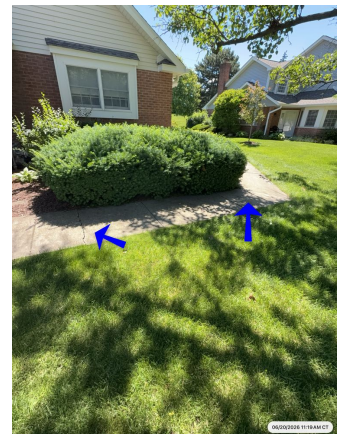
One or more walkway(s) in the referenced area(s) were observed to have moderate settling, creating uneven surfaces. The inspector recommends evaluating the walkway(s) and making repairs as needed to restore a level walking surface. Failure to address this condition may result in trip hazards and continued deterioration.

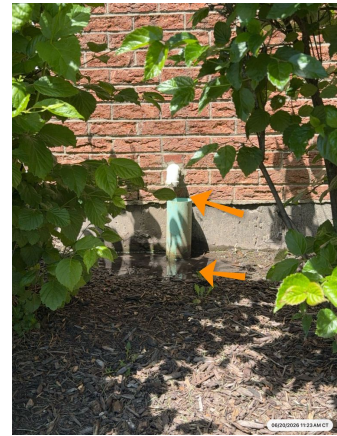
**Location:** Back Of Home

Additionally, misalignment may reduce the efficiency of the drainage system, leading to potential backup or overflow issues. The inspector recommends realigning and securing the discharge pipe to ensure proper water flow and prevent leaks near the foundation. Failure to address this issue may result in foundation moisture concerns, increased hydrostatic pressure, and potential long-term structural damage.

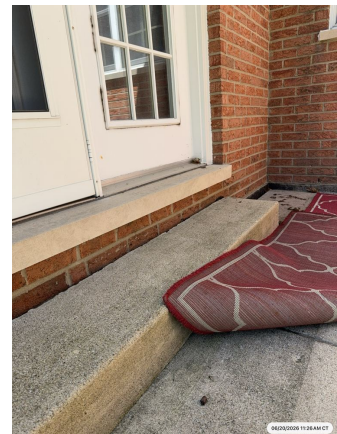
**Location:** Back Of Home

One or more step(s) leading to or from the patio in the referenced area(s) were measured with a rise greater than 7¾ inches, which exceeds the commonly accepted modern standard for step height. While this may have been typical at the time of construction, taller risers can pose a tripping hazard and reduce ease of use, particularly for children, older adults, or those with limited mobility. Although it may not have been a standard at the time of build, the inspector recommends considering reconfiguration of the step(s) to better align with modern safety practices. Failure to address this condition may result in increased risk of trips, falls, or injury.

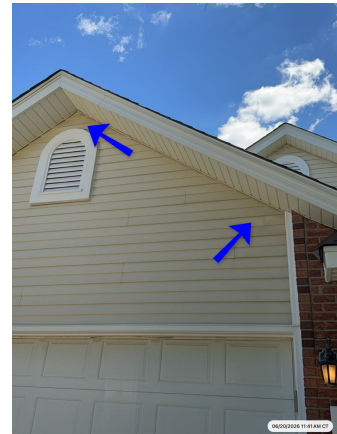
**Location:** Front Of Home , Back Of Home

One or more siding area(s) in the referenced area(s) were observed to be damaged, with visible cracks, dents, or missing sections. Siding serves as a protective barrier against moisture intrusion, weather elements, and pests, and any damage can compromise its effectiveness, potentially leading to deterioration of the underlying structure. The inspector recommends repairing or replacing the damaged siding to restore its protective function and prevent further deterioration. Failure to address this issue may result in moisture intrusion, structural damage, and reduced energy efficiency.

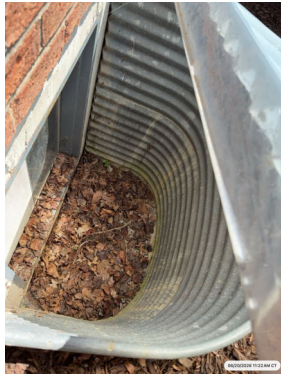
**Location:** Right Side of Home

One or more basement window wells contained debris, lacked a visible drainage system, had poorly fitted covers, and/or were missing a ladder where one would be needed for emergency egress. These conditions can allow water, debris, and pests to accumulate within the window well and may increase the potential for basement moisture intrusion. Missing egress ladders can also hinder emergency escape from basement living areas. Failure to address these deficiencies may result in water intrusion, reduced functionality of the window well system, and compromised emergency egress. The inspector recommends cleaning the affected window wells, verifying proper drainage, repairing or replacing poorly fitted covers, and installing an appropriately sized and secured ladder where required for safe emergency exit.

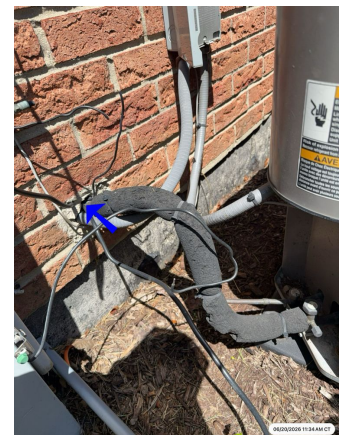
**Location:** All Sides

The exterior in the referenced area(s) was observed to have area(s) in need of sealant, which may compromise weather resistance and allow moisture intrusion. Areas lacking sealant, such as around windows, doors, or joints, can result from weathering, deterioration of existing sealant, or lack of maintenance over time, creating gaps that permit water to penetrate the exterior envelope. The inspector recommends evaluating the affected area(s) and making necessary adjustments, such as applying a high-quality exterior sealant to fill gaps and ensure a watertight barrier, to protect the structure and reduce air movement inside the home. If this issue isn't addressed, it may result in moisture intrusion, damage to the underlying materials, or mold growth over time.

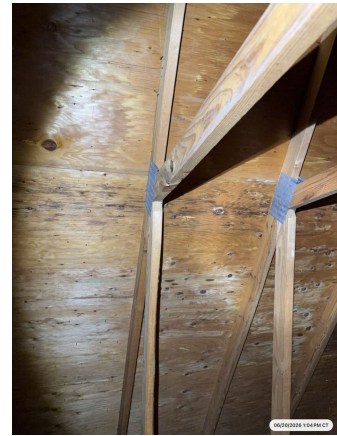
One or more area(s) of the attic were observed with dark or discolored surfaces, which may be indicative of elevated moisture levels and are presumed to be the result of insufficient ventilation. The discoloration may also represent possible microbial growth, which commonly develops in areas with poor air circulation and prolonged humidity. Poor attic ventilation can trap warm, moist air, leading to condensation on roof sheathing and framing members, which contributes to staining, microbial growth, and material deterioration over time. While no active leaks were confirmed at the time of inspection, the observed conditions suggest a need to evaluate and improve the current ventilation system. The inspector recommends enhancing attic ventilation—such as adding or clearing soffit, ridge, or gable vents—and further evaluating the discolored areas for microbial growth. Failure to address this issue may result in continued moisture buildup, mold development, reduced energy efficiency, and damage to attic materials.

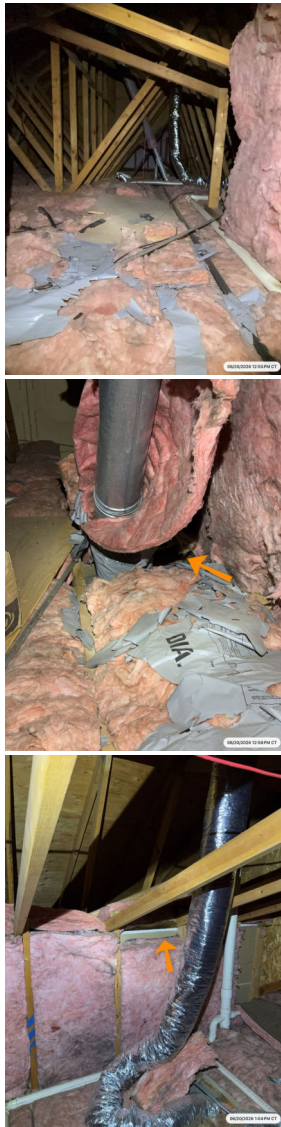
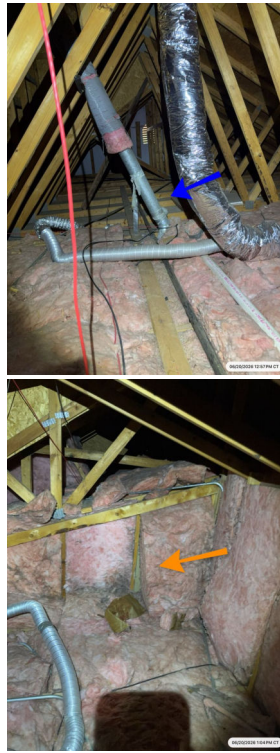
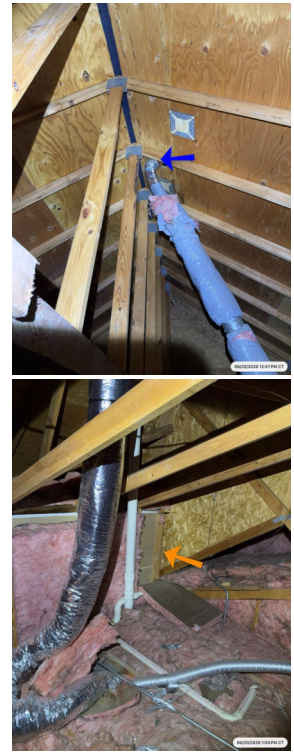
The attic insulation appeared to be below modern recommended levels, and areas of missing or sparse insulation were observed. Inadequate insulation can contribute to energy loss, uneven indoor temperatures, increased utility costs, and condensation-related moisture concerns during colder weather. Areas with incomplete insulation coverage may also create drafts and reduce the overall efficiency of the home's thermal envelope. Failure to address these conditions may result in continued energy inefficiency and reduced comfort. The inspector recommends adding insulation to achieve more consistent coverage and improving overall insulation levels to enhance energy performance and help reduce heat loss.

**Location:** Attic - All

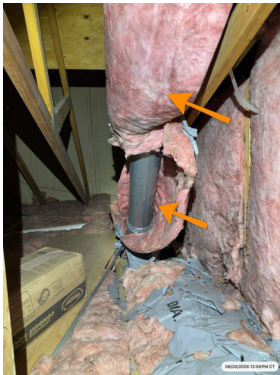
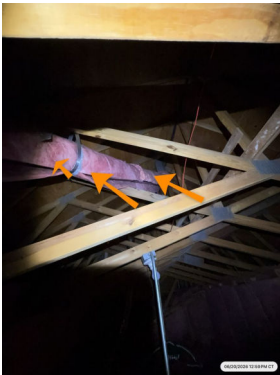
One or more presumed combustion vent(s) in the referenced area(s) were observed wrapped in insulation. Insulation in contact with a combustion vent can conceal the vent material and condition, interfere with proper heat dissipation, and may indicate improper clearance from combustibles materials. The venting system should be further evaluated and corrected as needed so proper clearances and installation can be confirmed. If not addressed, this condition can increase the risk of overheating, fire, or unsafe vent performance.

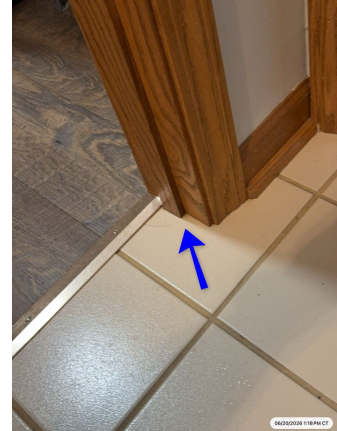
6.2.1 - Tile Flooring - Cracked Or Damaged (Location: Hallway)

The tile flooring in the referenced area(s) was observed to have cracked or damaged tiles, which may affect appearance and allow moisture to seep beneath. Cracked or damaged tiles can result from impact, settling of the subfloor, or improper installation over time, creating gaps or uneven surfaces that can permit water to penetrate and damage the underlayment. The inspector recommends evaluating the affected tile flooring and making necessary adjustments, such as replacing the cracked or damaged tiles and ensuring the subfloor is stable, to restore a seamless and watertight surface. If this issue isn't addressed, it may lead to further tile damage, moisture intrusion, or potential tripping hazards over time.

**Location:** Hallway

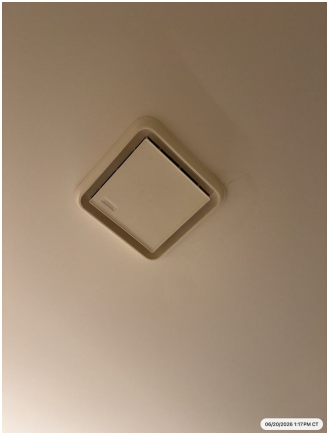
7.2.2 - Ventilation- Inadequate, Presumed Low CFM (Location: All)
-

The bathroom exhaust fan in the referenced area was observed to have inadequate ventilation due to low CFM, which may fail to effectively remove moisture and odors. Low cubic feet per minute (CFM) ratings can result from an undersized unit, age-related wear, or improper installation, reducing its capacity to manage humidity in the space. The inspector recommends evaluating the exhaust fan in the referenced area and replacing it with a unit of sufficient CFM to ensure proper air circulation. If this issue isn't addressed, it may lead to persistent moisture buildup, potential mold growth, or damage to finishes over time.

**Location:** All

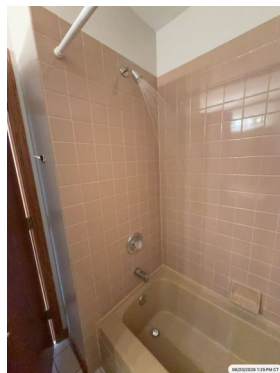
7.4.2 - Tub Surround-Damaged And Loose (Location: Hallway Bathroom, Master Bathroom)
-

One or more tub fixtures were loose, and loose tile and grout were observed in the tub/shower surround. Loose fixtures and deteriorated tile or grout can allow water to penetrate behind finished surfaces, potentially resulting in moisture damage, deterioration of surrounding materials, and conditions conducive to presumed microbial growth. Failure to address these conditions may lead to continued water intrusion and additional damage over time. The inspector recommends securing the affected fixtures and repairing or replacing the loose tile and grout as needed to help maintain a watertight enclosure and prevent further deterioration.

**Location:** Hallway Bathroom, Master Bathroom

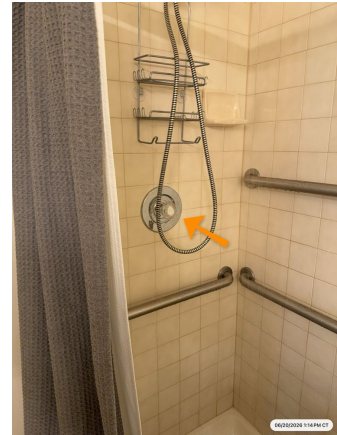
One or more shower(s) in the referenced area(s) were observed to have the hot and cold water reversed at the mixing valve. This condition may occur due to improper installation, incorrect supply line routing, or a misaligned cartridge within the valve assembly, and it can cause the shower to deliver hot water first when water is initiated instead of cold, increasing the risk of scalding. The inspector recommends evaluating the shower mixing valve system and correcting the supply orientation or internal components as needed. Failure to address this issue may result in inconsistent water temperature control and an increased potential for scalding or discomfort during use.

**Location:** Master Bathroom

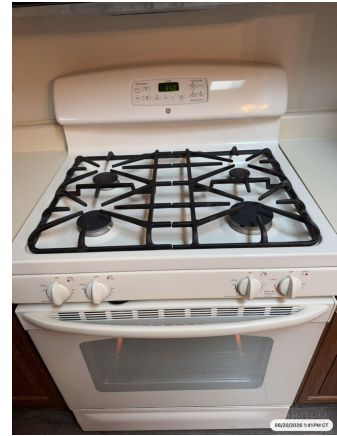
The range in the referenced area(s) was observed to lack an anti-tip bracket or have none installed, which may pose a safety hazard. The absence of an anti-tip bracket, meant to secure the range to the floor or wall to prevent tipping, can result from oversight during installation, removal, or an older appliance setup, increasing the risk of the range tipping over if a door is used as a step or during heavy use. The inspector recommends evaluating the range and making necessary adjustments, such as installing an anti-tip bracket according to the manufacturer's specifications, to ensure stability. If this issue isn't addressed, it may lead to the range tipping, potential injury, or damage to the appliance or surrounding area.

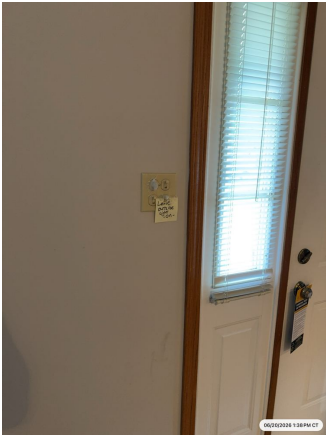
One or more switch(es) in the referenced area(s) were observed but their function could not be determined at the time of inspection. This may be due to a a receptacle controlled toggle covered by furniture, disconnected circuit, an uninstalled or removed fixture. The inspector recommends consulting the homeowner for clarification or testing the circuit to determine its purpose, any toggle with unknown function should be evaluated and repaired, as needed. Failure to address this issue may result in confusion over switch functionality, potential safety concerns if the switch controls an important system, or inconvenience in daily use.

Location: Living Room , Kitchen

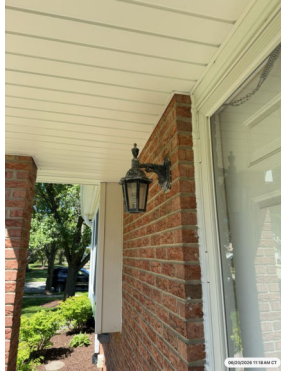
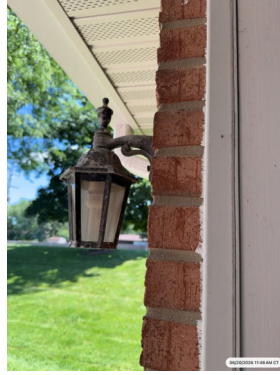
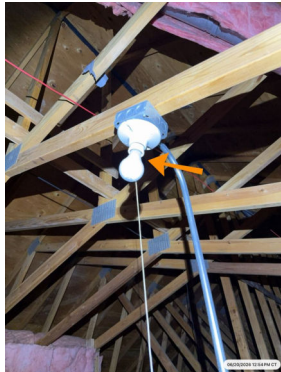
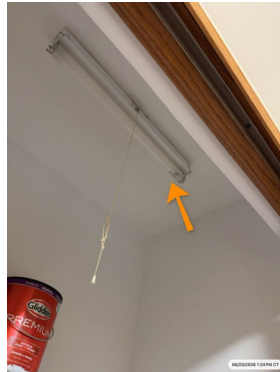
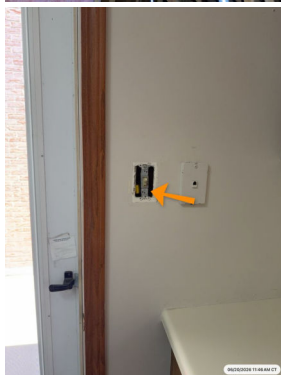
#### 10.1.3 Electrical Fixtures- Damaged Or Inoperable

Repair Recommended / Moderate Concern

**Location:** Front Of Home, Back of Home, Basement, Attic, Laundry Room Closet, Living Room, Back Entry

proper cover plates where missing.

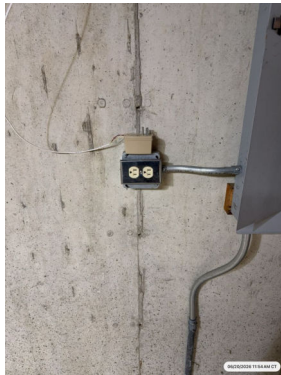
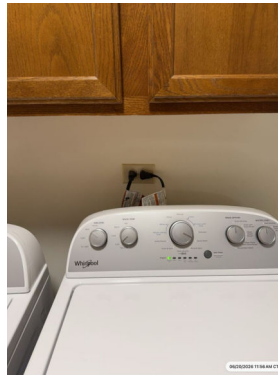
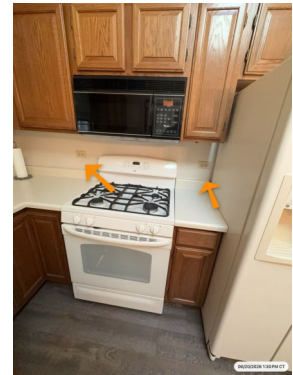
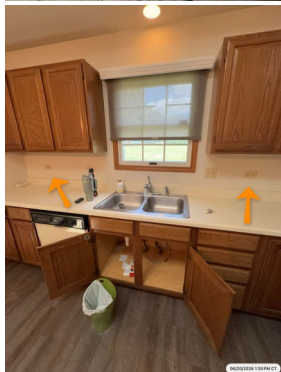
It is important to note, the inspector does not recommend installing GFCI receptacles for sump pumps, injector pits or any refrigerator/ freezer.

**Location:** Basement - All , Laundry Room, Kitchen Countertops

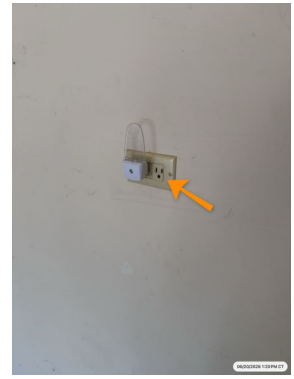
## 10.2.2 GFCI(s)- Failed To Trip

**Location:** Front Of Home, Back Of Home , , Garage

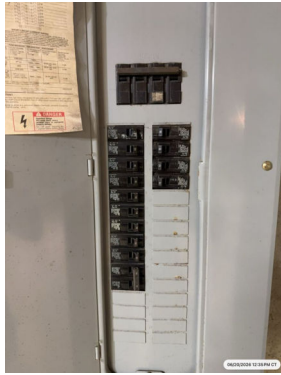
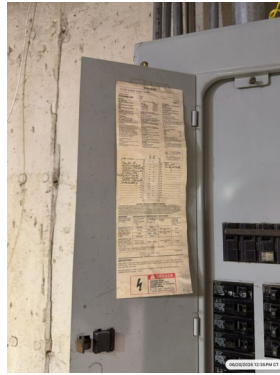
#### 10.3.1 Picture Of Service Panel Prior To Inspection: Picture Attached

*The home's electrical panel was found in the following condition (represented with the picture.)*

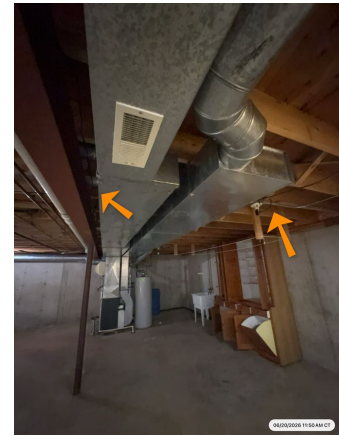
## 10.7.2 Wiring - Extension

**Location:** Basement

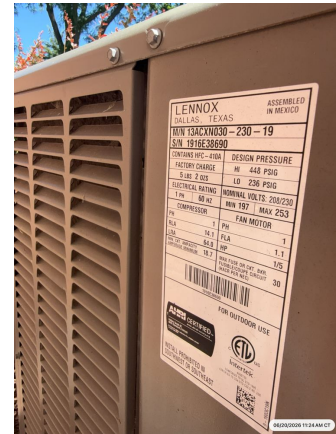
### 11.1.4 PICTURE- Air Conditioner Data Plate: Picture Attached

Information from the air-conditioner condenser unit data plate is shown in the photo.

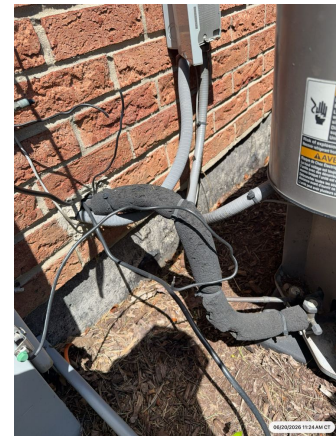
The AC refrigerant suction line insulation in the referenced area(s) was observed to be damaged or missing in some area(s), which may reduce the system's efficiency and lead to energy loss. Proper insulation is essential to maintain energy efficiency, prevent condensation buildup, and ensure optimal cooling performance. This issue may be caused by wear and tear, weather exposure, or physical damage. The inspector recommends evaluating the refrigerant suction line and making necessary adjustments, such as replacing the damaged or missing insulation with proper foam pipe insulation, to restore thermal protection. If this issue isn't addressed, it may result in reduced cooling efficiency, increased energy costs, or strain on the AC system over time.

**Location:** Exterior

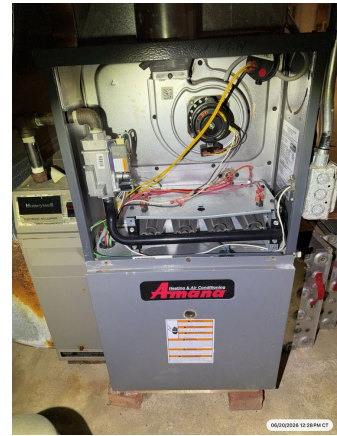
The interior unit was observed to be dirty and in need of servicing. Dirt and debris buildup can reduce the efficiency of the system, strain its components, and impair its ability to heat the home effectively. Regular servicing is essential to maintain proper performance, extend the lifespan of the unit, and ensure safe operation. The inspector recommends cleaning and servicing the unit to restore its functionality and efficiency. Failure to address this issue may result in reduced performance, increased energy costs, and potential mechanical failure.

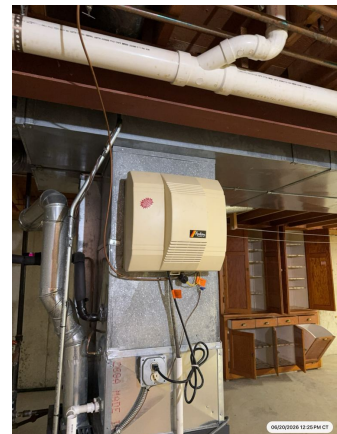
One or more humidifier(s) in the referenced area(s) were observed to be inoperable, or the water shut-off may be off—if so, the inspector is unable to turn the valve on—which may prevent proper humidity control in the home. An inoperable humidifier can result from a closed water supply, a malfunctioning valve, electrical failure, or lack of maintenance, often due to age or neglect, leaving the home without adequate moisture regulation. The inspector recommends evaluating the humidifier(s), including the water shut-off valve, and making necessary adjustments, such as turning on the water supply if safe to do so, repairing or replacing faulty components, or installing a new unit, to restore functionality. If this issue isn't addressed, it may lead to overly dry indoor air, discomfort, or potential damage to wood furnishings or flooring during drier months.

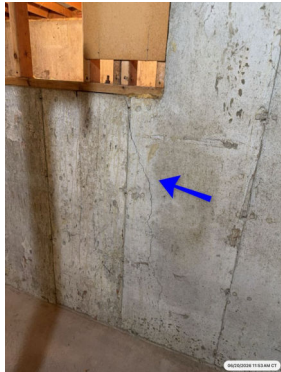
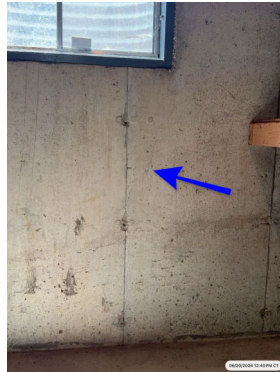
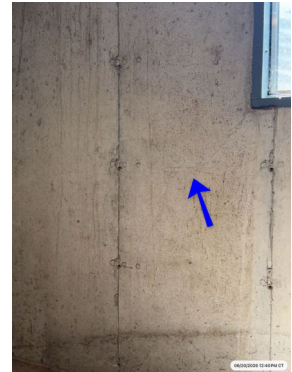
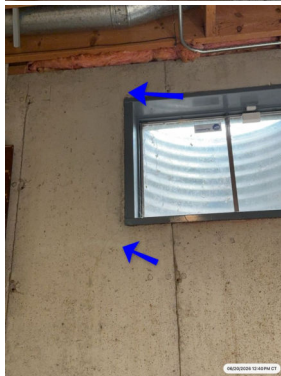
**Location:** Basement

One or more minor crack(s) were observed in the foundation walls, which are typically associated with normal settling, shrinkage, or temperature-related expansion and contraction. These types of cracks are common and do not appear to compromise the structural integrity of the foundation at this time. The inspector recommends monitoring the cracks for any signs of widening or movement over time and sealing them to prevent moisture intrusion. Failure to address this issue may result in potential water infiltration, further crack propagation, and deterioration of the foundation surface.

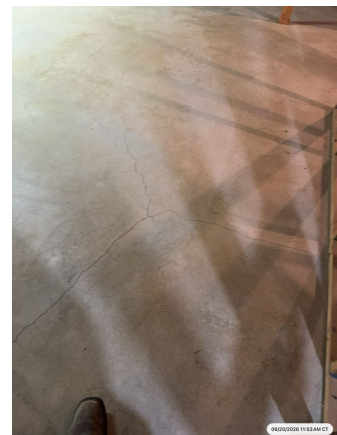
One or more crack(s) were observed in the slab in the referenced area(s). Cracks in concrete slabs are common and may occur due to normal shrinkage, settlement, thermal expansion, or age-related wear. While many cracks are cosmetic, wider or uneven cracks can allow moisture intrusion, contribute to further deterioration, or pose a trip hazard. The inspector recommends evaluating the cracked areas to determine if sealing or repair is warranted. Failure to monitor or address slab cracks may lead to continued expansion, potential water intrusion, and reduced longevity of the garage floor.

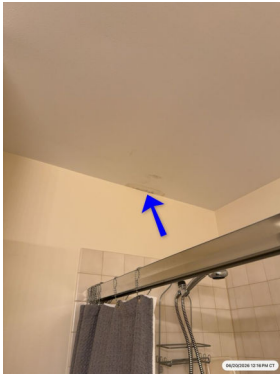
Location: Master Bathroom, Basement

#### 13.1.1 Staining In Area(s)- Previous Or Intermittent Moisture Intrusion- Dry At Inspection- Monitor

Staining was observed in the referenced area(s), consistent with previous or intermittent moisture intrusion. The affected surfaces were dry at the time of inspection, and no active moisture was detected. While the staining suggests past moisture exposure, the source could not be confirmed during the inspection. The inspector recommends monitoring the area for signs of recurring moisture and evaluating further if staining worsens or moisture returns. Failure to monitor this condition may result in undetected moisture intrusion and potential damage to surrounding materials.

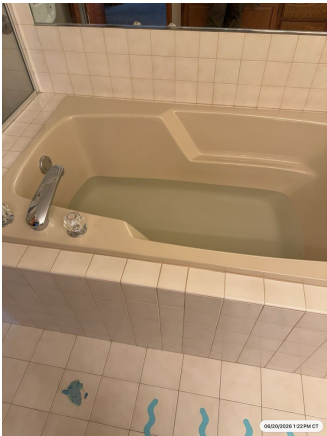
Location: Master Bathroom Tub

Hindered (slow) drainage was observed in one or more referenced fixture(s) at the time of inspection. This condition may result from partial blockages due to debris, buildup within the drain line, improper venting, or inadequate pipe slope. Slow drainage can lead to standing water, unpleasant odors, and reduced fixture performance. The inspector recommends evaluating the affected drain(s), clearing any obstructions, and verifying proper venting and slope. Failure to address this condition may result in continued drainage issues, potential backups, and damage to plumbing components or finishes.

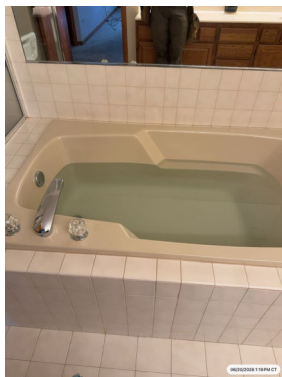
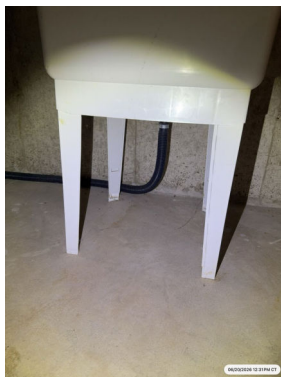
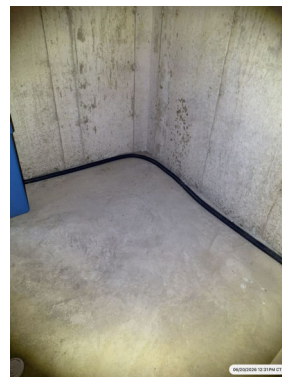
**Location:** Master Bathroom Tub, Basement Sink

### 14.2.1 DWV-Improper Drainage Repairs

Improper DWV piping was observed at the basement sink, including the use of flexible piping, evidence of leakage, and drainage that discharged directly into the sewage ejector pit without a proper trap. A drain in the master bathroom also produced minor gurgling during operation, which may indicate a venting or drainage irregularity. Improperly installed drain piping can allow leaks, sewer gas entry, and unreliable drainage performance. The inspector recommends correcting the affected plumbing using proper materials and installation methods and repairing any associated leaks. Failure to address these conditions may result in continued leakage, odors, and reduced drainage performance.

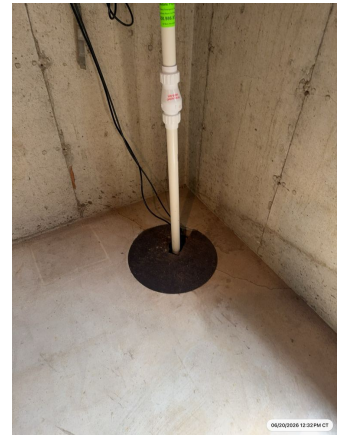
**Location:** Basement

### 14.6.2 Back-Up System- None-Recommended

The sump pump was observed to lack a backup system, which may leave the home vulnerable to flooding during power outages or primary pump failure. This condition increases risk due to potential electrical disruptions or mechanical issues, common during heavy rain or snowmelt, which could prevent the pump from removing water effectively. Although a backup system is not required, the inspector highly recommends installing a backup pump with a battery backup system to ensure continuous operation and protect the basement from water damage. If this issue isn't addressed, it may result in significant moisture intrusion, structural damage, or mold growth, particularly during prolonged outages or severe weather events.

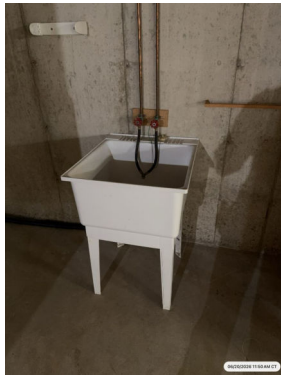
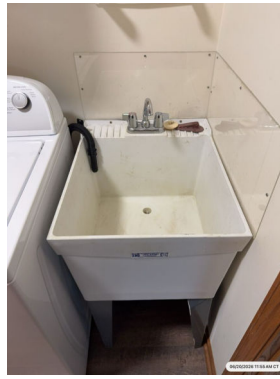
**Location:** Basement , Laundry Room

#### 14.10.2 Sink- Loose, Not Secured

One or more sink(s) in the referenced area(s) were observed to be loose and not secured, which may lead to instability or plumbing issues. A loose sink can result from weakened mounting hardware, deterioration of supports, or improper installation, causing it to shift during use, especially in high-traffic areas. The inspector recommends evaluating the sink(s) and securing it properly, such as by tightening or replacing mounting brackets, to ensure stability. If this issue isn't addressed, it may result in further loosening, damage to plumbing connections, or potential detachment over time.

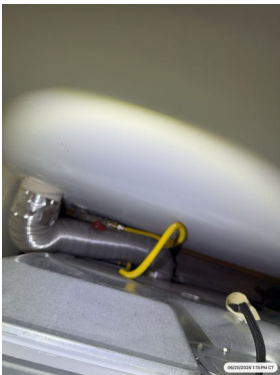
16.3.1 Flex Or Foil Duct

The dryer was observed to have a flex or foil duct for venting. Flex and foil ducts are not recommended for dryer venting as they are prone to lint buildup, reduced airflow, and potential fire hazards due to their flammable material and ribbed design. Modern standards recommend rigid or semi-rigid metal ducts for safer and more efficient venting. The inspector recommends replacing the flex or foil duct with a rigid or semi-rigid metal duct to improve airflow and enhance safety. Failure to address this issue may result in increased fire risk, reduced dryer efficiency, and higher maintenance needs due to lint accumulation.

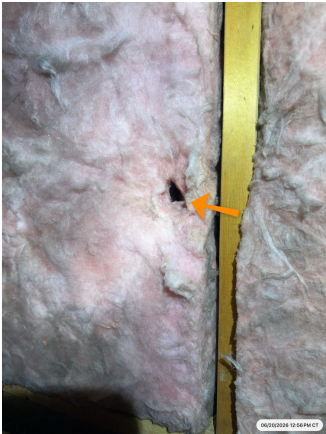
**Location:** Attic , Basement , Crawlspace

Evidence of rodent activity was observed in the referenced area(s), which may have included droppings, nesting material, gnawed surfaces, or other indicators. Rodents can enter homes through small openings and are known to cause damage by chewing on insulation, wiring, and building materials. Their presence also poses health risks due to potential contamination from urine, feces, and parasites. Areas with insulation affected by rodents should be evaluated, removed, and replaced if needed. The inspector recommends evaluating the affected areas, sealing potential entry points, and consulting with a pest control professional for removal and prevention measures. Failure to address this issue may result in ongoing infestations, property damage, and health concerns for occupants.

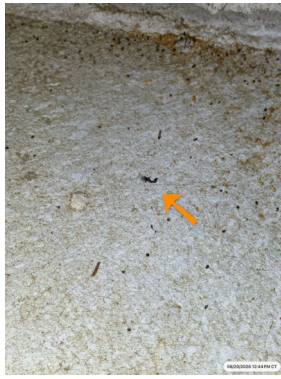
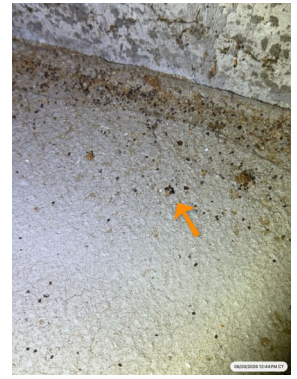
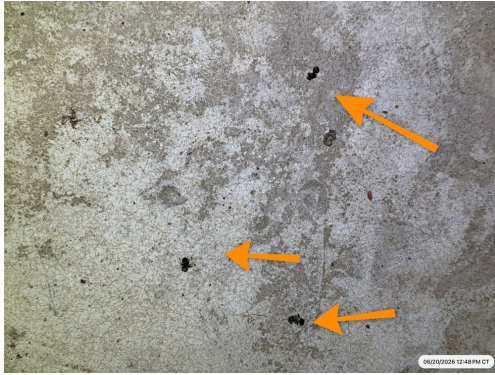
#### 17.1.3 Dead Carpenter Ant(s) Observed

**Location:** Crawlspace , Basement

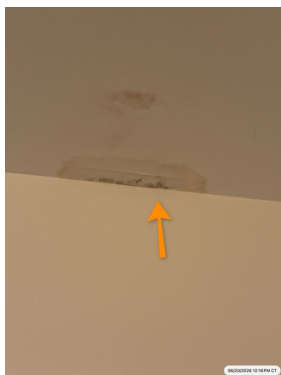
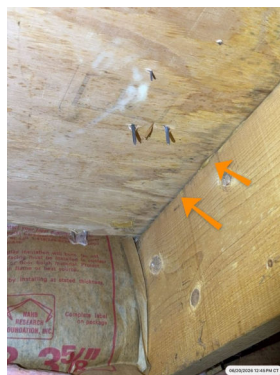
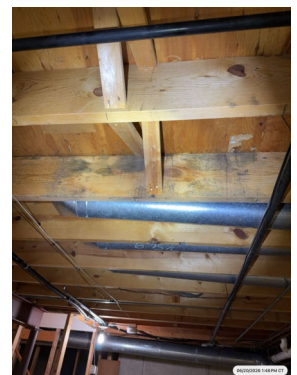
**Location:** Master Bathroom , Crawlspace, Basement

Presumed microbial growth was observed in the master bathroom, crawlspace, and basement. Discoloration and staining were noted above the shower in the master bathroom, and additional areas of presumed microbial growth were observed on building materials within the crawlspace and basement. The presence of presumed microbial growth typically indicates current or past moisture exposure and may contribute to deterioration of affected materials and reduced indoor air quality. The inspector recommends identifying and correcting any moisture-related conditions contributing to the growth and cleaning, repairing, or replacing affected materials as needed to help prevent further deterioration.

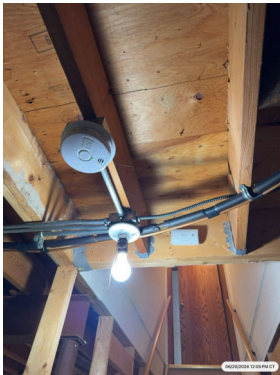
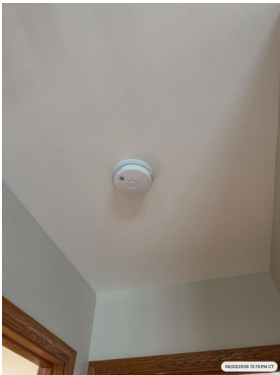
#### 18.1.1 Smoke Detector Locations- PICTURES: 1st floor, Basement

Please follow the illustrations below on proper placement for carbon monoxide, smoke detectors and fire extinguishers. At Ease Inspections recommends replacing all smoke detectors in the home regardless of age with the recently mandated 10 year smoke/CO detectors. If you ever have any questions or concerns, please contact us immediately/CO detector placement is important and we want you to be safe!

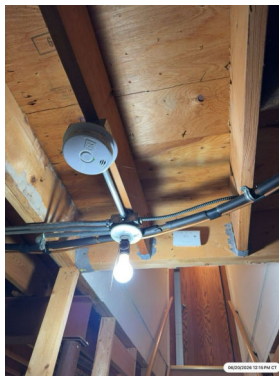
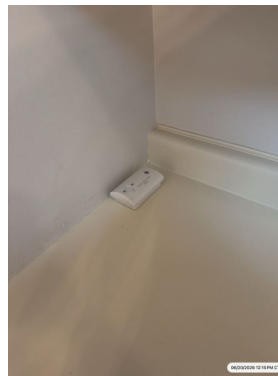
#### 18.2.1 Carbon Monoxide Detectors Present- PICTURES: Basement, Kitchen

*The inspector recommends a CO detector is on every floor of the home. Please be aware, the inspector will not test smoke and carbon monoxide detectors during the inspection. The inspector highly recommends one of the first things homeowners do when occupying a home is testing CO and smoke detector in the home. The inspector actively monitors CO levels throughout the inspection and can only report conditions present at time of inspection.*

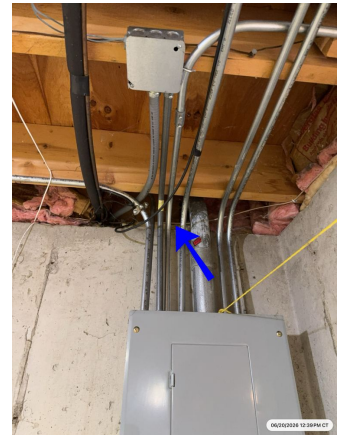
**Location:** Basement - Back Of Home

The foundation exterior walls in the referenced area(s) were observed to have area(s) above grade with no or missing insulation, which may lead to energy loss and temperature inconsistencies in the home. Missing insulation on above-grade foundation walls can result from original construction oversight, removal during repairs, or deterioration over time, allowing heat to escape or cold air to infiltrate through the exposed areas. The inspector recommends evaluating the foundation exterior walls and making necessary adjustments, such as adding insulation like rigid foam board or spray foam to the above-grade sections, to improve energy efficiency. If this issue isn't addressed, it may result in increased energy costs, drafts, or potential condensation issues during colder weather.

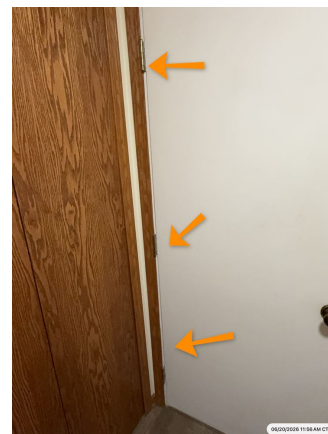
The garage door leading to the living space was observed to lack self-closing hinges. Self-closing hinges are recommended for doors separating garages from living areas to help reduce the risk of vehicle exhaust fumes, carbon monoxide, and potential fire hazards from entering the home. Proper self-closing mechanisms help ensure the door remains closed automatically after use. Although it may not have been a required at time of build, the inspector recommends installing self-closing hinges to enhance safety and improve the barrier between the garage and the living space. Failure to address this issue may result in reduced fire resistance and increased safety risks due to fume infiltration.

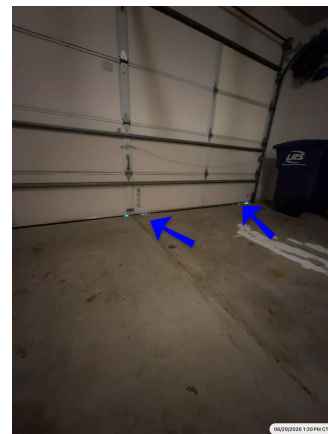
One or more garage overhead door(s) in the referenced area(s) were observed to have exterior seal(s) that are damaged or deteriorated, which may reduce weather resistance and allow pests, air or moisture to enter the garage. Damaged or deteriorated seals can result from weathering, UV exposure, or wear over time, creating gaps that permit drafts, water, or pests to infiltrate. The inspector recommends evaluating the affected seal(s) and making necessary adjustments, such as replacing the damaged or deteriorated seals with new weatherstripping, to restore a proper barrier. If this issue isn't addressed, it may lead to energy loss, moisture intrusion, or pest entry into the garage over time.

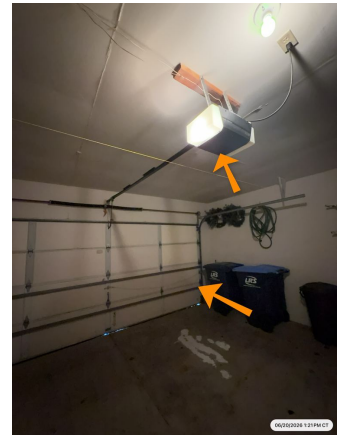
The garage overhead door opener did not have modern safety features, such as an automatic reversing system and/or photoelectric safety sensors. These safety devices are designed to help prevent the door from closing on people, pets, vehicles, or other obstructions. Failure to provide these protections increases the risk of injury and property damage. The inspector recommends upgrading the garage door opener system to include modern safety features that comply with current safety standards.
