## SEWER SCOPE INSPECTION

123 Sample Street, Demo City, ST 12345

6/12/2026 5:51AM

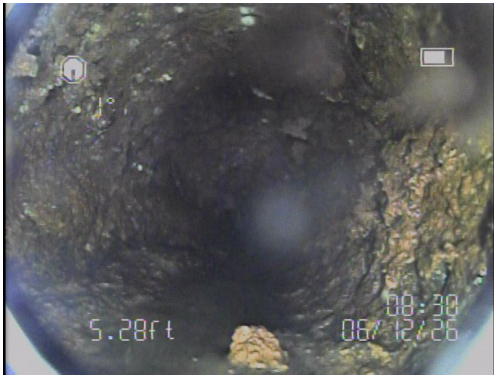
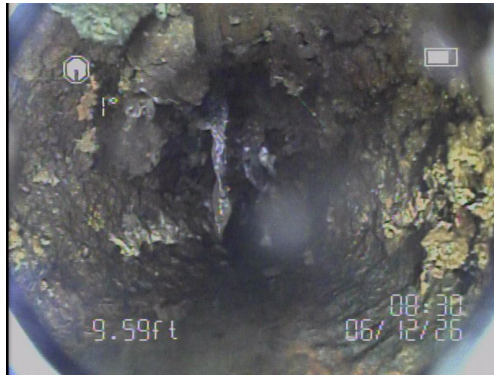
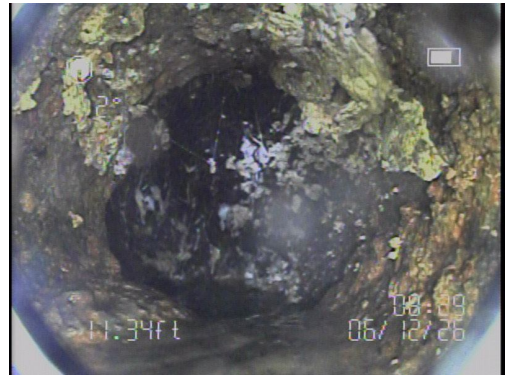
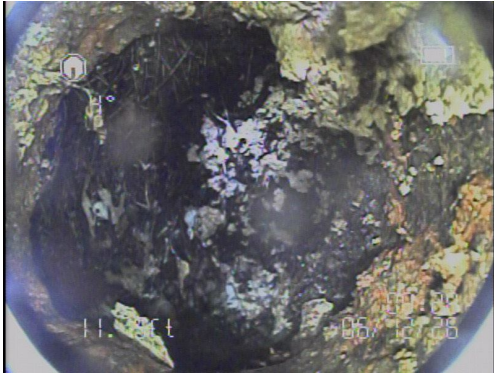
#### 1.3.2 Picture(s): Picture(s) Uploaded To Report

*The picture(s) attached to this section are of the sewer inspection performed on the agreed home.*
