At Ease Inspections

## HOME INSPECTION REPORT

123 Sample Street, Demo City, ST 12345

6/18/2026 5:21AM

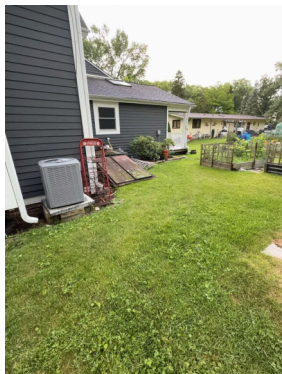
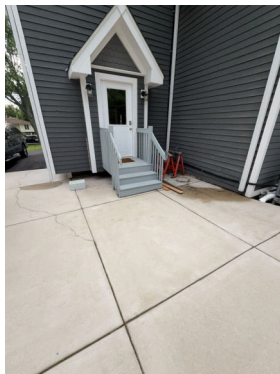
**Location:** Back Of Home

Negative or neutral grading was observed near the structure, including soil and/or hard-surfaced areas that slope toward the home. These conditions can allow water to collect near the foundation, increasing the potential for moisture intrusion, seepage, erosion, and premature deterioration of building materials. Continued water accumulation around the foundation may also contribute to basement or crawlspace moisture concerns. The inspector recommends regrading the affected areas and/or installing appropriate drainage measures to promote positive drainage away from the structure.

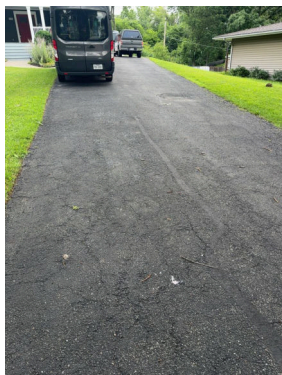
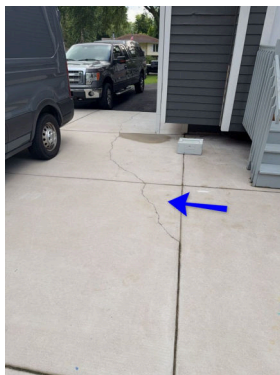
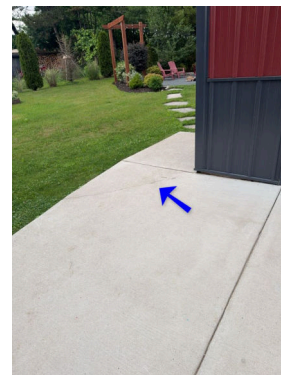
**Location:** All

The asphalt driveway exhibited typical age-related deterioration, including surface wear, weathering, and minor cracking. While these conditions are common as asphalt ages, they can allow moisture intrusion into the pavement structure, accelerating deterioration and potentially contributing to uneven surfaces, water retention, trip hazards, or icy conditions during colder weather. Routine maintenance can help extend the service life of the driveway and slow further deterioration. The inspector recommends sealing and repairing cracks as needed, addressing any drainage concerns, and budgeting for future repairs or eventual replacement as the driveway continues to age.

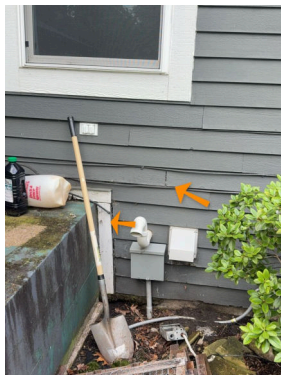
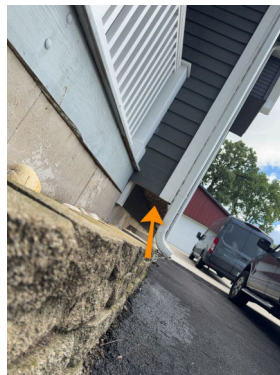
**Location:** Right Side Of Home, Porch

Moderate deterioration was observed in portions of the wood siding, and one or more overhangs, bay windows, bump-outs, or exterior wall areas lacked proper sealing, paint protection, and/or visible weather-resistive barrier materials. These conditions leave exterior components more vulnerable to moisture intrusion, rot, insect activity, air leakage, and concealed deterioration within wall assemblies. Continued exposure to weather can accelerate damage and may result in more extensive repairs if not addressed. The inspector recommends repairing or replacing deteriorated siding, properly sealing and painting exposed materials, and correcting areas where the weather-resistive barrier is missing or compromised to help restore the exterior envelope and protect the structure from moisture intrusion.

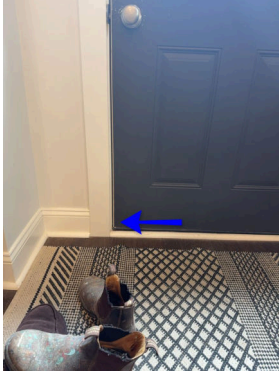
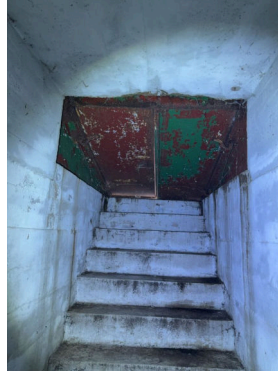
**Location:** Back Doors, Basement

One or more exterior doors exhibited gaps around the frame and/or threshold, and one or more doorways were installed below grade without adequate drainage provisions. These conditions can allow drafts, moisture intrusion, and pest entry while also increasing the likelihood of water accumulation at the doorway. Continued exposure to moisture may result in deterioration of door components, interior finishes, and adjacent building materials. The inspector recommends sealing and adjusting the affected doors as needed to restore a weather-tight seal and improving drainage at below-grade door locations to help direct water away from the structure and reduce the potential for leakage.

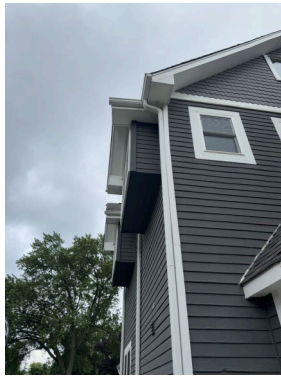
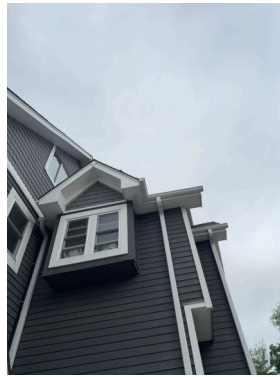
The soffit vents in the referenced area were observed to be insufficient in number, which may restrict proper attic ventilation. Limited soffit vents can stem from original design, subsequent modifications, or obstructions, reducing airflow needed to regulate temperature and moisture in the attic space. The inspector recommends evaluating the soffit and attic ventilation system and adding more vents to improve circulation. If this issue isn't addressed, it may lead to excessive heat buildup, moisture retention, or

premature deterioration of roofing materials over time

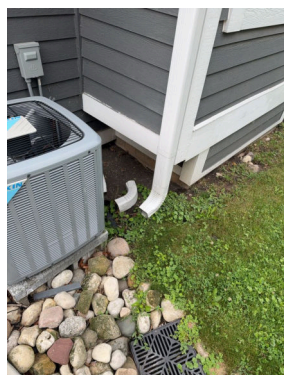
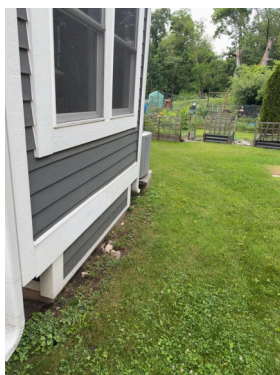
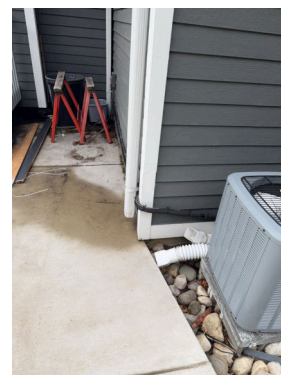
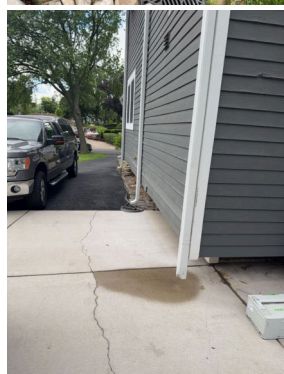
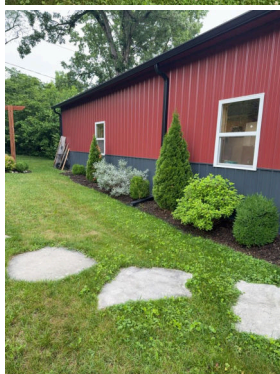
**Location:** All, Garage, House

The gutter system contained debris, and all downspouts discharged too close to the foundation. Clogged gutters can restrict proper drainage and cause water to overflow at the roof edge, while downspouts that terminate near the structure can allow water to accumulate around the foundation. These conditions may contribute to moisture intrusion, erosion, settlement, and premature deterioration of exterior building components. The inspector recommends cleaning the gutters and extending the affected downspouts to discharge water at least 4 to 6 feet away from the foundation to help improve drainage and reduce the potential for moisture-related concerns.

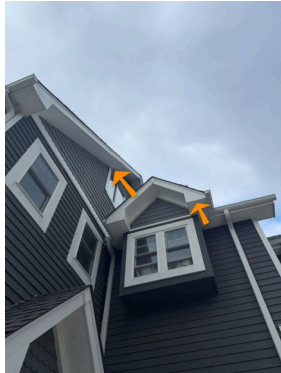
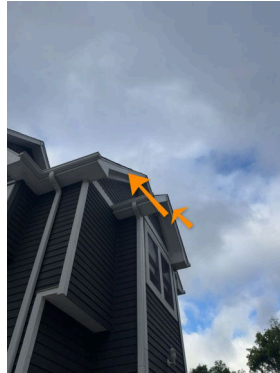
**Location:** Gable Ends

One or more areas of the roof were observed to be missing a drip edge. A drip edge is a metal flashing installed along the edges of the roof to direct water away from the fascia and into the gutters, preventing moisture intrusion, wood rot, and deterioration of roofing components. Although it may not have been a standard at the time of build, the inspector recommends installing a properly sized drip edge to improve water management and protect the roof structure. Failure to address this issue may result in water damage to the fascia, soffits, and underlying roof decking, potentially leading to costly repairs over time.

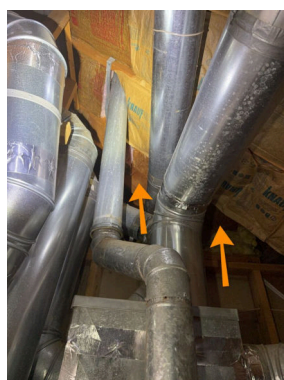
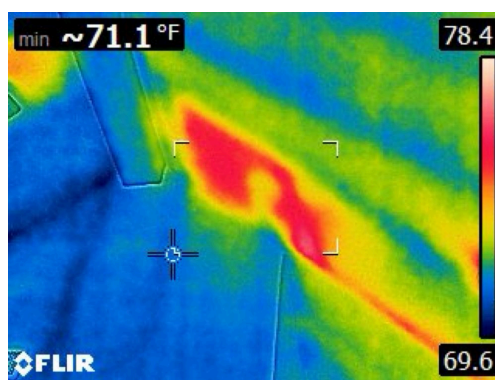
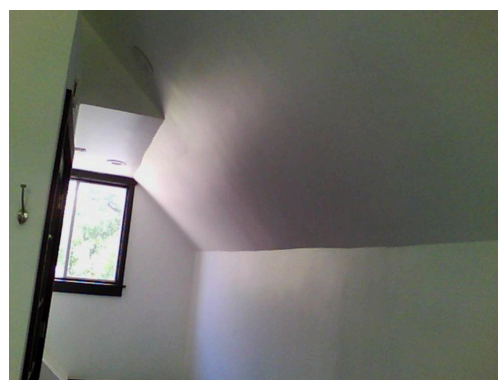
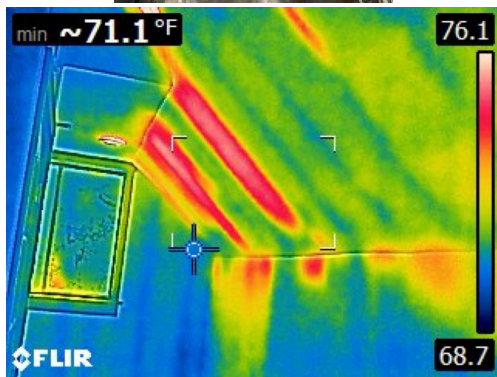
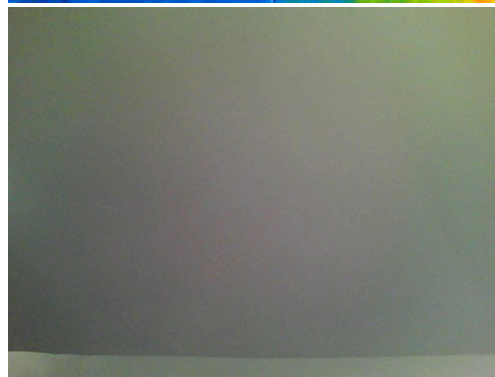
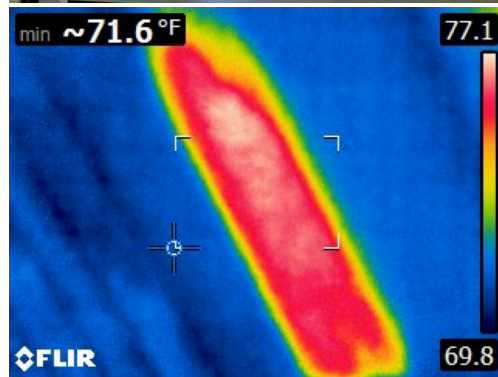
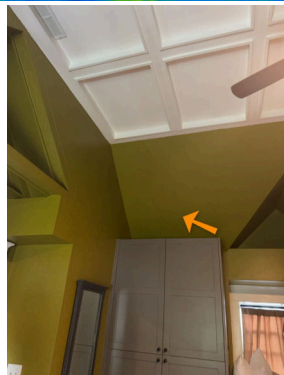
**Location:** Attics/ Finished Areas

The attic(s) in the referenced area(s) were observed to have insulation that is missing or sparse in some area(s), which may lead to energy loss and temperature inconsistencies in the home. Missing or sparse insulation can result from incomplete installation, settling over time, or disturbance during maintenance, leaving gaps or thin coverage that allow heat to escape or cold air to infiltrate. The inspector recommends evaluating the attic insulation and making necessary adjustments, such as adding insulation to fill the missing or sparse area(s) to achieve the recommended R-value for the region, to improve energy efficiency. If this issue isn't addressed, it may result in increased energy costs, drafts, or potential condensation issues during colder weather.

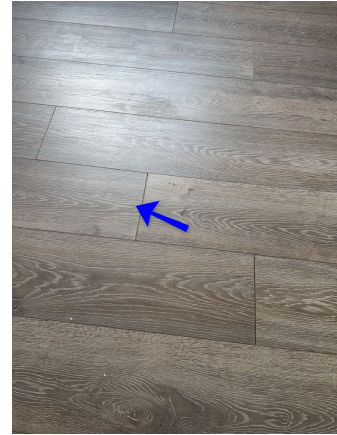
**Location:** 3rd Floor

#### 6.2.1 General Deterioration, Gap(s)

The flooring in the referenced area(s) was observed to exhibit general deterioration with gap(s), which may affect appearance and allow moisture or debris to accumulate. General deterioration and gaps in flooring can result from age, wear, or temperature-related expansion and contraction, often depending on the material, creating spaces that can trap dirt or permit moisture to seep beneath. The inspector recommends evaluating the affected flooring and making necessary adjustments, such as filling the gap(s) with a compatible sealant, refinishing or repairing the deteriorated areas, or replacing the flooring if necessary, to restore a seamless surface. If this issue isn't addressed, it may lead to further deterioration, moisture intrusion, or potential tripping hazards over time.

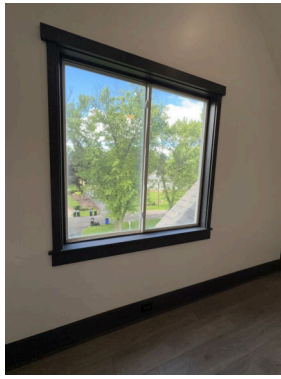
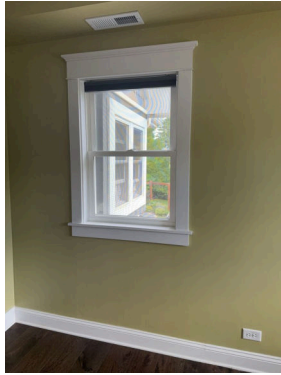
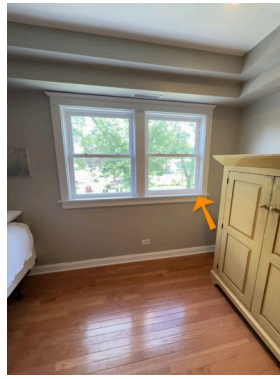
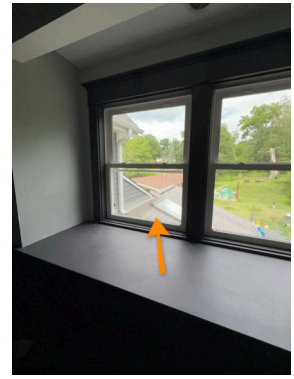
**Location:** 3rd Floor, Bedroom- Front of Home, 2nd Floor Hallway, Bedrooms

One or more window(s) in the referenced area(s) were observed to not lock, which may compromise the security of the home, potentially due to foundation settlement. A window that will not lock can result from a broken or misaligned lock mechanism, a warped frame caused by foundation settlement shifting the structure, or wear over time, preventing the window from being securely fastened when closed. The inspector recommends evaluating the affected window(s) and making necessary adjustments, such as repairing or replacing the lock mechanism, adjusting the frame alignment, or addressing any underlying foundation issues, to ensure proper security. If this issue isn't addressed, it may lead to an increased risk of unauthorized entry, reduced safety, or the need for more extensive repairs over time.

**Service:** Window Repair Installation Contractor

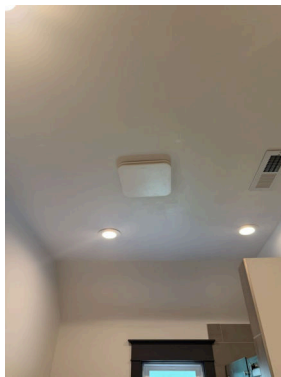
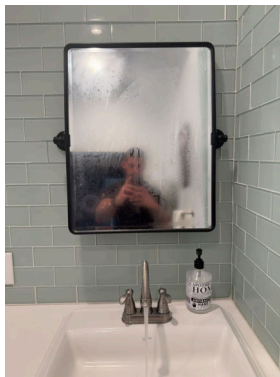
**Location:** 2nd Floor Bathroom

##### 7.2.2 Ventilation- Inadequate, Presumed Low CFM

The bathroom exhaust fan in the referenced area was observed to have inadequate ventilation due to low CFM, which may fail to effectively remove moisture and odors. Low cubic feet per minute (CFM) ratings can result from an undersized unit, age-related wear, or improper installation, reducing its capacity to manage humidity in the space. The inspector recommends evaluating the exhaust fan in the referenced area and replacing it with a unit of sufficient CFM to ensure proper air circulation. If this issue isn't addressed, it may lead to persistent moisture buildup, potential mold growth, or damage to finishes over time.

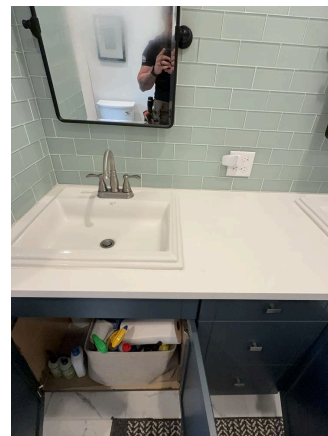
**Location:** 2nd Floor Bathroom

One or more bathroom sink(s) or surrounding area(s) in the referenced area(s) were observed to require caulk maintenance, which may allow moisture to seep into adjacent materials and cause damage. Deteriorated or missing caulk around the sink or surrounding area can result from age, wear, or exposure to moisture over time, creating gaps that permit water to penetrate into countertops, walls, or cabinetry. The inspector recommends evaluating the affected area(s) and making necessary adjustments, such as removing old caulk and applying new, high-quality caulk to seal the gaps, to prevent moisture intrusion. If this issue isn't addressed, it may lead to moisture intrusion, damage to the surrounding structure, or mold growth over time.

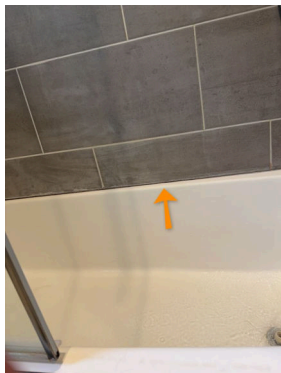
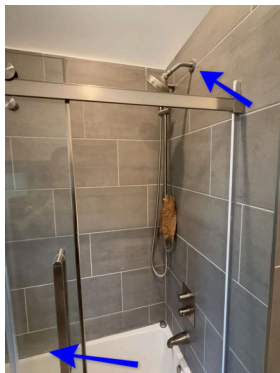
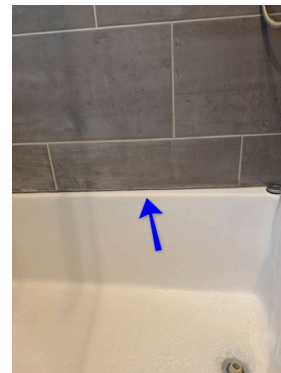
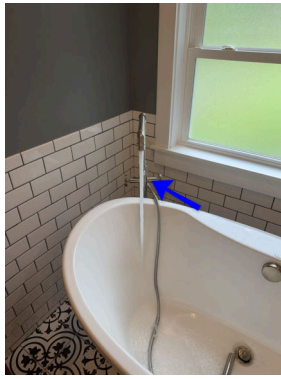
#### 7.4.1 Tub(s)-Sealant And Fixture Deficiencies

Failed caulk and/or grout was observed at the tub surround, and one or more tub fixtures were loose at the time of inspection. These conditions can allow water to bypass finished surfaces and enter surrounding wall or floor assemblies, potentially resulting in moisture damage, deterioration of concealed materials, and conditions conducive to presumed microbial growth. Loose fixtures may also place additional stress on plumbing connections and increase the potential for leakage over time. The inspector recommends recaulking and repairing grout as needed, securing the affected fixtures, and correcting any associated damage to help prevent further moisture intrusion.

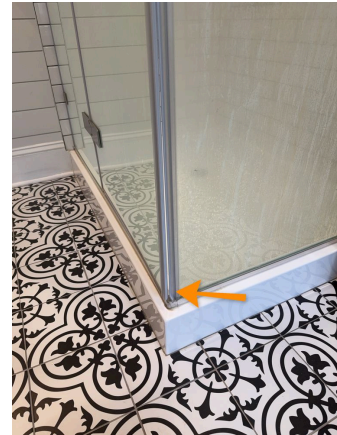
**Location:** 1st Floor Bathroom

#### 7.5.1 Shower Door Or Enclosure(s)- Gaps(s), Loose Or Poorly Sealed

One or more shower door(s) or enclosure component(s) were observed with gaps, looseness, or poor sealing. Improperly sealed or loose enclosures can allow water to escape during use, leading to moisture intrusion, staining, or damage to surrounding finishes. The inspector recommends evaluating the shower door and enclosure system and making repairs or resealing as needed to restore a watertight condition. Failure to correct this condition may result in continued leakage, deterioration of adjacent materials, and potential mold growth.

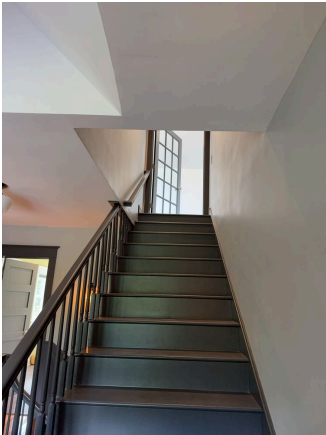
**Location:** 2nd Floor To 3rd Floor

##### 8.1.1 Staircase(s)- Overhead Hazards(s)

One or more staircase(s) in the referenced area(s) were observed to have overhead hazard(s), which may pose a risk of injury if not noticed. While this condition is common in older homes, low clearances above staircases can increase the likelihood of head injuries, especially for taller individuals. The inspector recommends exercising caution when using the stairs and considering modifications, such as padding the obstruction or adjusting the clearance if feasible. Failure to address this issue may result in accidental injuries and reduced accessibility.

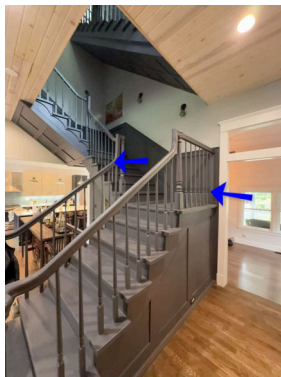
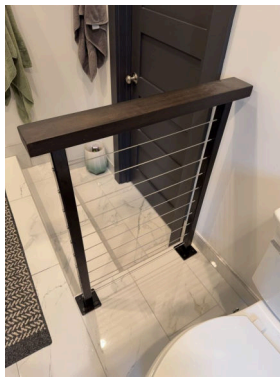
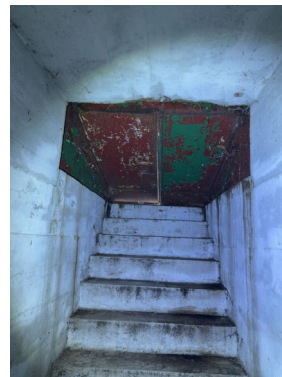
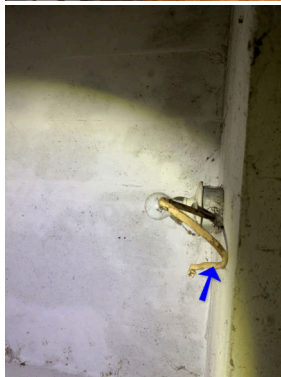
**Location:** 1st Floor To 2nd Floor, 2nd Floor Bathroom, Basement- Back Of Home

##### 8.1.3 Staircase And Guardrail Safety Deficiencies

Safety deficiencies were observed at the staircase and guardrail system, including loose or inadequately secured guardrails, horizontal balusters that create a climbable ladder-like pattern, and the absence of permanent stair lighting. These conditions increase the risk of slips, trips, falls, and injury, particularly for children and during periods of reduced visibility. Guardrails that are not adequately secured may not safely resist normal loading, while climbable guardrail designs can increase the likelihood of falls from elevated surfaces. The inspector recommends reinforcing or replacing the affected guardrail components as needed, modifying the baluster configuration to reduce climbability, and installing permanent lighting at the staircase to improve visibility and overall safety.

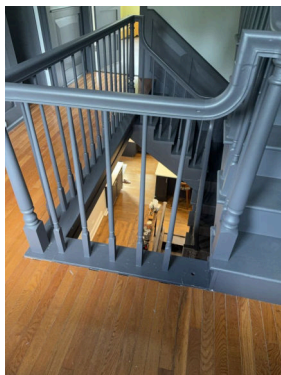
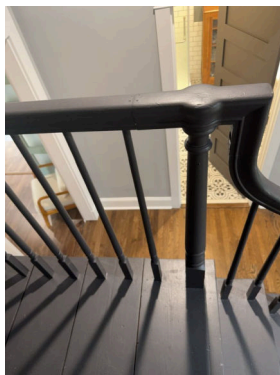
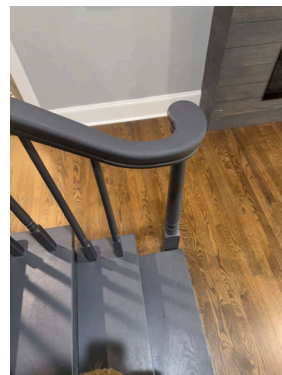
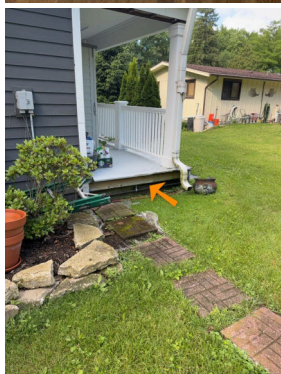
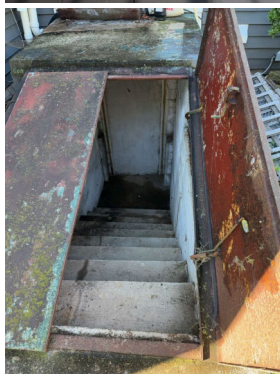
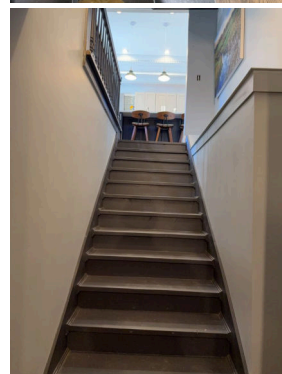
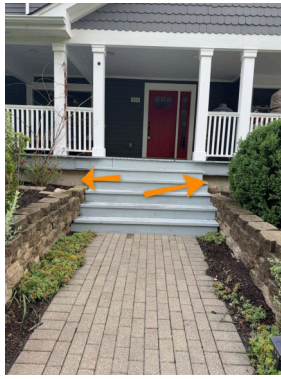
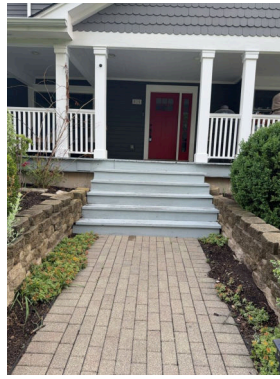
**Location:** All, Porch, Basement, Front Of Home

#### 8.1.4 Missing Handrails/Guardrails, Step > 7 3/4, Baluster Spacing

Multiple safety concerns were observed at the staircase, including baluster spacing that exceeded modern safety standards, risers that were taller than recommended, and missing handrails and/or guardrails. These conditions can increase the risk of slips, trips, falls, and entrapment, particularly for children, elderly occupants, and individuals with mobility limitations. Wide baluster spacing may allow children or pets to pass through or become trapped, while non-uniform or excessively tall risers can create unexpected tripping hazards during normal use. The inspector recommends modifying the baluster spacing, correcting the stair geometry where practical, and installing properly configured handrails and guardrails at the affected locations to improve safety and reduce the potential for injury.

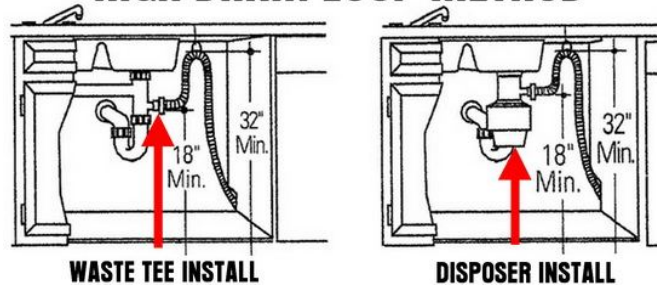
## HIGH DRAIN LOOP METHOD

##### 9.2.1 Secondary Anti-Siphon- None Or Improper High Loop

Although modern dishwashers are equipped with internal anti-siphon mechanisms, the inspector recommends installing an additional external backflow prevention measure for added protection. A high loop is a simple and effective method to prevent wastewater from backing up into the dishwasher. The drain line should be routed to the highest point beneath the sink, securely affixed to the underside of the counter with a bracket, and then directed downward into the garbage disposal or sink drain. Installing a proper high loop helps ensure proper drainage and prevents potential contamination. Failure to address this issue may result in improper dishwasher drainage, unpleasant odors, or unsanitary conditions within the appliance.

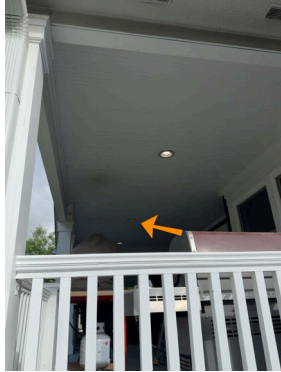
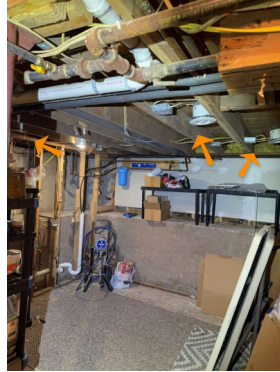
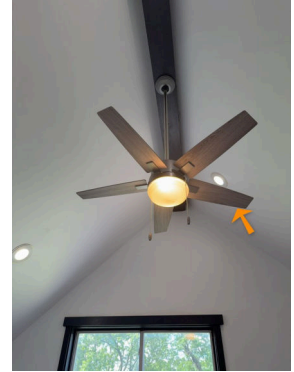
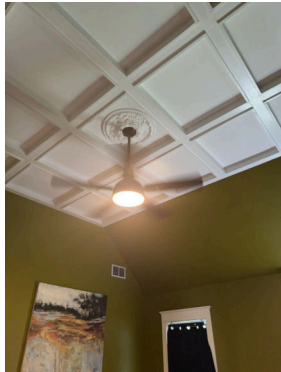
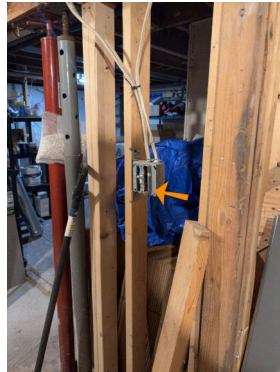
**Location:** Porch, Basement, 3rd Floor Fan, Master Bedroom

#### 10.1.3 Electrical Fixtures - Operational and Cover Defects

One or more electrical fixtures were inoperable, ceiling fans exhibited excessive wobble during operation, and electrical cover plates were missing in the referenced areas. Inoperable fixtures may indicate failed components or underlying electrical issues, while wobbling ceiling fans can place additional stress on mounting hardware and increase wear on the fan assembly. Missing cover plates leave electrical components exposed, increasing the potential for accidental contact, shock, injury, or damage. Failure to address these conditions may result in continued operational issues and reduced electrical safety. The inspector recommends repairing or replacing the inoperable fixtures, securing and adjusting the affected ceiling fans, and installing proper cover plates at

all exposed electrical devices.

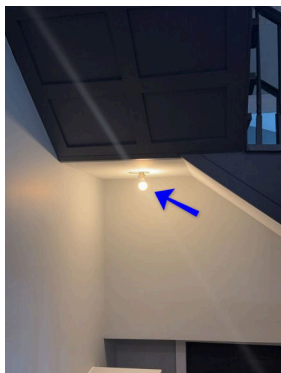
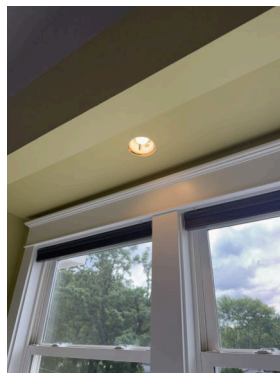
#### 10.1.4 Light Fixture(s)-Loose Or Missing Cover

One or more light fixtures were loose, hanging, and/or missing the proper cover or globe at the time of inspection. Loose fixtures may become further detached over time, creating a risk of damage or injury, while missing covers leave bulbs and internal components more susceptible to accidental contact and physical damage. These conditions may also affect the intended operation and protection of the fixture. The inspector recommends properly securing the affected fixtures and installing the appropriate covers or globes to restore safe and reliable operation.

**Location:** 1st Floor To Basement Staircase, Bedrooms, Basement

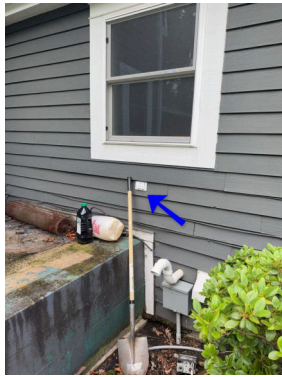
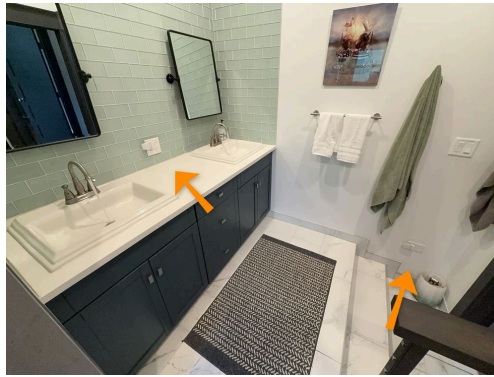
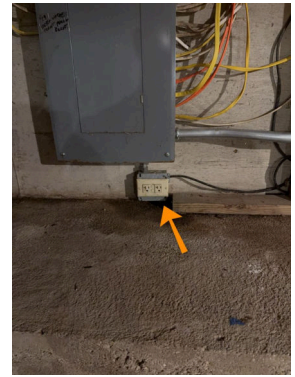
#### 10.2.2 GFCI Protection Deficiencies

One or more receptacle(s) in the referenced area(s) were observed to lack GFCI protection, and one or more GFCI receptacles failed to trip or respond properly during testing. These conditions may not comply with modern standards for electrical safety in areas prone to moisture. The absence of functional ground-fault circuit interrupter protection can stem from older construction, failed devices, or updates that did not include this safeguard, leaving the receptacle(s) vulnerable to ground faults without automatic shutoff. The inspector recommends evaluating the receptacle(s) and electrical system, and making necessary adjustments, such as installing GFCI receptacle(s), replacing defective GFCI devices, or adding GFCI protection upstream, to enhance safety. If these issues are not addressed, they may increase the risk of electrical shock or injury, particularly in environments exposed to dampness or frequent water use.

It is important to note, the inspector does not recommend installing GFCI receptacles for sump pumps, injector pits, or refrigerator/freezer receptacles.

**Location:** Exterior, Garage, Basement, 2nd Floor Bathroom

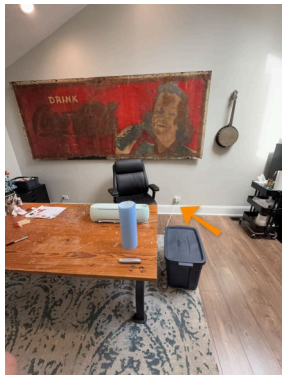
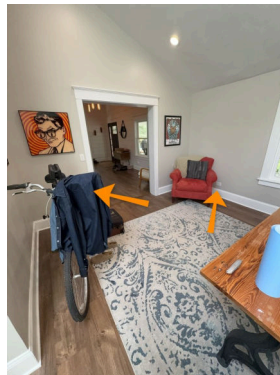
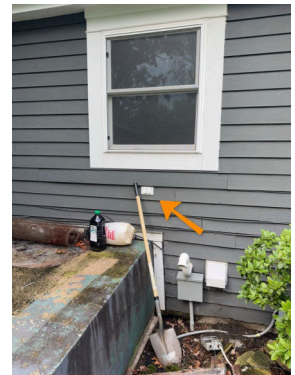
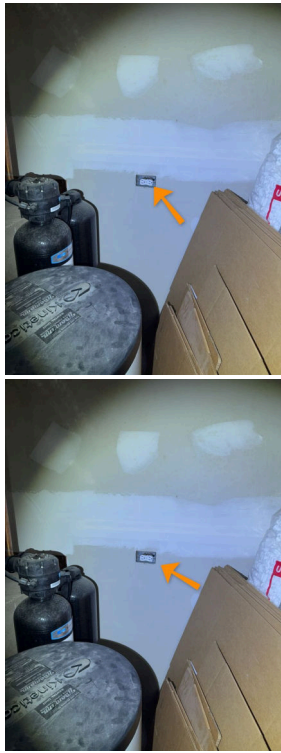
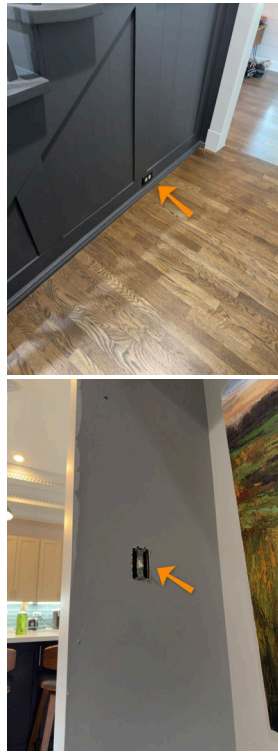
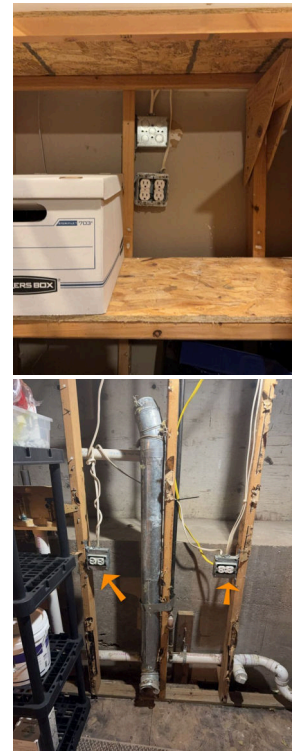
#### 10.3.2 Receptacles-Multiple Defects

One or more receptacles were found to be ungrounded, inoperable, loose at the wall or electrical box, and/or missing cover plates. These conditions can create shock, arcing, overheating, and fire hazards while also reducing the reliability and intended functionality of the electrical system. Ungrounded receptacles may not provide adequate protection for occupants or sensitive electronic equipment, inoperable receptacles may indicate underlying electrical deficiencies, and loose devices can result in poor electrical connections. Missing cover plates leave energized components more accessible and increase the potential for accidental contact. Failure to correct these conditions may result in reduced electrical safety and an increased risk of injury or property damage. The inspector recommends evaluating and repairing the affected receptacles, securing loose devices, installing missing cover plates, and providing proper grounding or approved GFCI protection where grounding cannot be readily installed.

**Location:** 1st Floor Front Room, Back Of Home, Basement, 1st Floor Hallway, Staircase

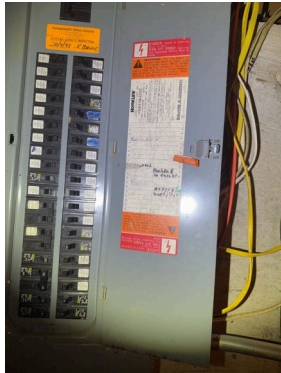
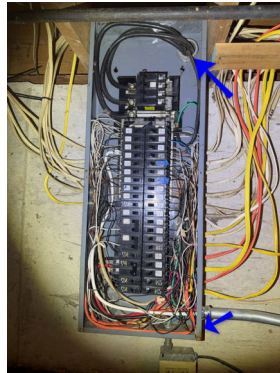
### 10.4.5 Service Panel-Labeling, Corrosion, Grounding Defects

The electrical panel had missing or incomplete circuit labeling, minor corrosion, and grounding conductors that were double-tapped or terminated under shared lugs not intended for multiple conductors. In addition, evidence of moisture intrusion was observed within the panel enclosure, including presumed microbial growth and conditions suggesting moisture entry through an unsealed raceway or other opening. These conditions can reduce the reliability of the electrical system, contribute to loose connections, overheating, corrosion of electrical components, and create conditions conducive to continued deterioration if moisture intrusion persists. Failure to address these deficiencies may result in reduced electrical safety and reliability over time. The inspector recommends properly identifying and labeling all circuits, correcting the grounding conductor terminations, evaluating and addressing any corrosion or damaged components, sealing the raceway and other potential moisture entry points, and further evaluating the presumed microbial growth and moisture intrusion to help prevent future deterioration of the electrical equipment.

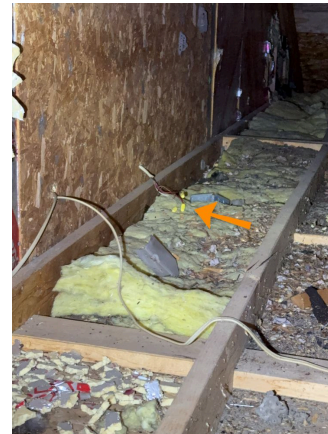
One or more splice(s) in the referenced area(s) were observed to be not contained in junction box(es), which may pose an electrical safety hazard. Exposed splices can result from improper installation, repairs, or wear, leaving wires unprotected and susceptible to contact, short-circuiting, or damage, especially in accessible or high-traffic areas. The inspector recommends evaluating the splice(s) and installing junction box(es) to enclose them securely. If this issue isn't addressed, it may lead to electrical shocks, fire risks, or damage to the wiring system over time.

**Location:** Porch Attic,

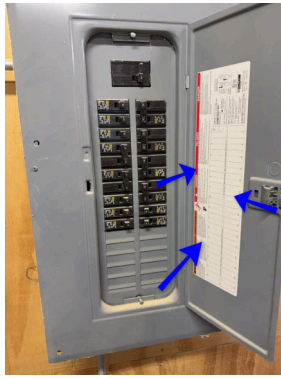
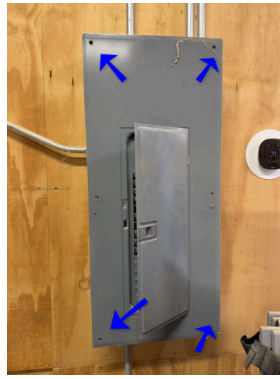
### 10.10.6 Subpanel-Lable & Cover Screws Missing

The subpanel had missing or incomplete circuit identification and was missing one or more cover screws at the time of inspection. Inadequate labeling can make it difficult to quickly identify and de-energize circuits during maintenance, troubleshooting, or emergency situations, while missing cover screws may allow the panel cover to become loose and increase the potential for accidental contact with energized components. Failure to correct these conditions may reduce the safety and serviceability of the electrical system. The inspector recommends updating the panel legend to accurately identify all circuits and installing the proper panel cover screws to securely fasten the enclosure.

**Location:** Garage

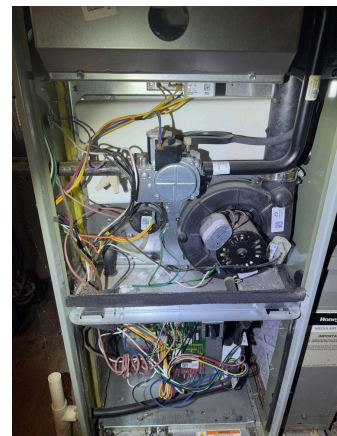
The furnace was observed to be dirty and in need of servicing. Dirt and debris buildup can reduce the efficiency of the furnace, strain its components, and impair its ability to heat the home effectively. Regular servicing is essential to maintain proper performance, extend the lifespan of the unit, and ensure safe operation. The inspector recommends cleaning and servicing the furnace to restore its functionality and efficiency. Failure to address this issue may result in reduced performance, increased energy costs, and potential mechanical failure.

**Location:** Basement

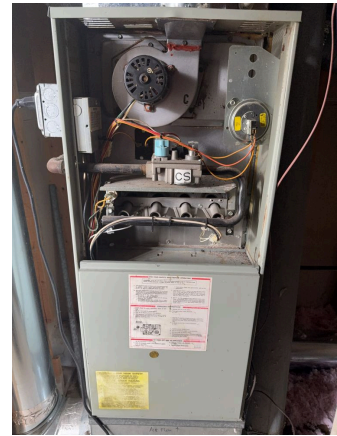
The furnace located in the third-floor attic, which serves the second and third floors, responded to cooling demands and the blower fan operated normally; however, the unit failed to produce heat at the time of inspection. The burner assembly did not ignite when a call for heat was initiated, preventing normal heating operation. As a result, the affected areas may be unable to maintain adequate indoor temperatures during colder weather, and the underlying cause of the failure could involve one or more components within the ignition, control, or safety systems. The inspector recommends further evaluation and repair of the furnace by a qualified HVAC contractor prior to closing. Failure to correct this condition may result in a loss of heating capability and potential damage associated with inadequate temperature control during cold weather.

**Location:** 3rd Floor Attic

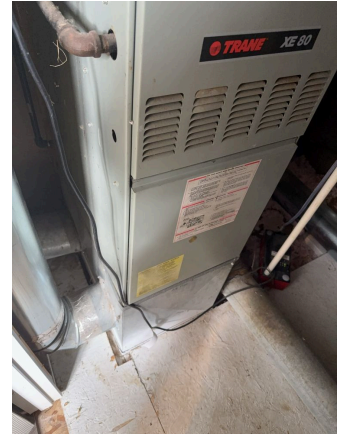
One or more furnace(s) in the referenced area(s) were observed to be installed above finished living space without an auxiliary drip pan or secondary drain. Furnaces and associated evaporator coils can produce condensate during normal operation, and leakage from internal components, drain lines, or fittings can occur. When installed above finished areas, the absence of a secondary containment system increases the risk of moisture damage to ceilings and interior finishes below. An auxiliary drain pan with proper discharge piping is intended to help capture and redirect condensate in the event of primary drain failure. The inspector recommends evaluating the installation and adding appropriate secondary protection as needed. Failure to address this condition may result in concealed leakage and damage to finished living areas.

**Location:** 3rd Floor

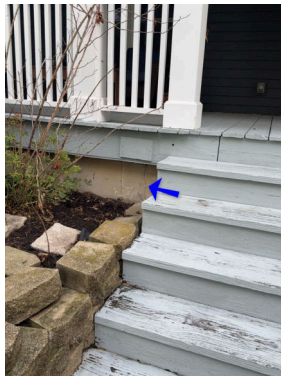
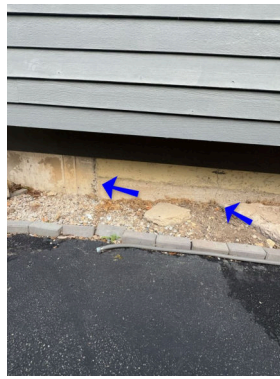
**Location:** Front Of Home , , Right Side Of Home

One or more exterior foundation crack(s) in the referenced area(s) were observed to be minor, which may warrant monitoring to ensure stability. Minor cracks can result from natural settling, temperature changes, or soil shifts, typically appearing as hairline fractures in concrete or masonry, especially in homes exposed to seasonal weather variations. The inspector recommends evaluating the crack(s), monitoring them over time for changes in size or severity, and considering sealing the cracks to prevent moisture entry, with further repairs if progression occurs. If this issue isn't addressed, it may remain stable but could potentially indicate larger structural concerns or allow moisture intrusion if worsening is observed over time.

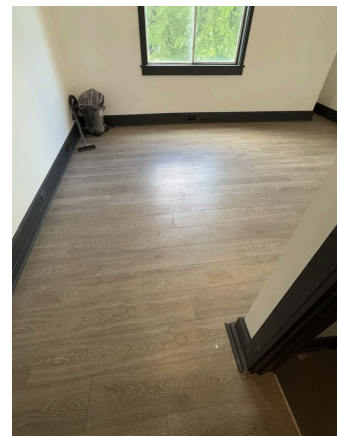
**Location:** 2nd Floor , 3rd Floor

One or more interior floor area(s) in the referenced area(s) were observed to be sloped or not level. The inspector was unable to access or visually assess the underlying framing members to determine the exact cause due to concealed conditions. Sloped floors are relatively common and may result from settlement, framing deflection, construction methods, or other factors. No significant cracking was observed in association with this condition at the time of inspection. The inspector recommends evaluating the structure beneath the floor if concerns arise or if access becomes available. Continued movement, if present, may result in uneven flooring or other related issues.

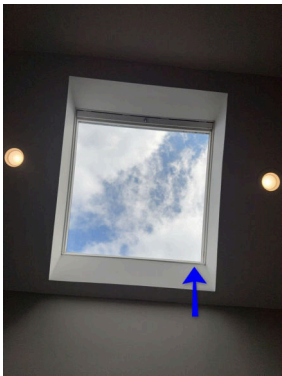
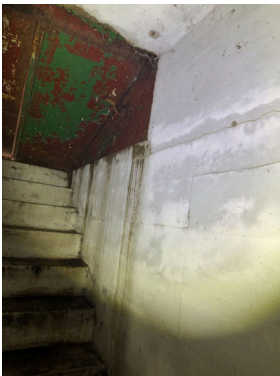
Location: Skylight, Basement

13.1.1 Staining In Area(s)- Previous Or Intermittent Moisture Intrusion- Dry At Inspection- Monitor

Staining was observed in the referenced area(s), consistent with previous or intermittent moisture intrusion. The affected surfaces were dry at the time of inspection, and no active moisture was detected. While the staining suggests past moisture exposure, the source could not be confirmed during the inspection. The inspector recommends monitoring the area for signs of recurring moisture and evaluating further if staining worsens or moisture returns. Failure to monitor this condition may result in undetected moisture intrusion and potential damage to surrounding materials.

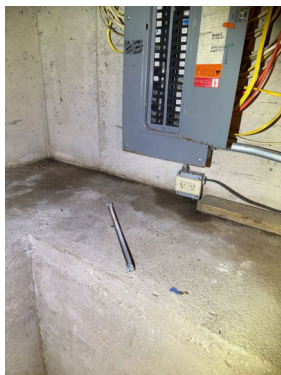
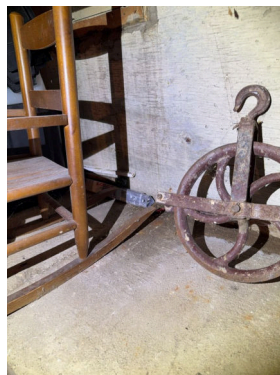
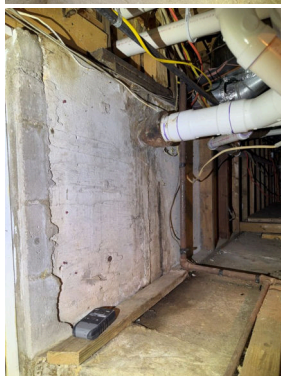
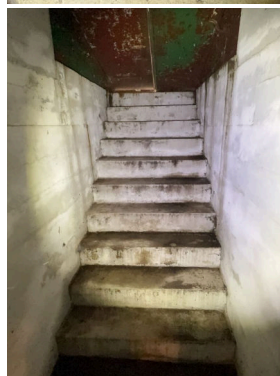
**Location:** Basement - Back Of Home

#### 13.3.2 Foundation Wall(s)- Active Moisture Intrusion

Active moisture intrusion was observed in portions of the basement, including areas along the rear foundation wall. Moisture staining, dampness, and evidence of water entry were noted at the time of inspection. Contributing factors may include foundation wall cracks, negative grading at the rear of the home, and water intrusion at the cellar door area, where conditions appeared conducive to water entry. In some locations, evidence of moisture was present but the exact source could not be definitively determined at the time of inspection.

Active moisture intrusion can contribute to deterioration of building materials, presumed microbial growth, and damage to interior finishes if allowed to persist. The inspector recommends identifying and correcting the sources of water entry, which may include improving exterior drainage and grading, repairing foundation cracks, addressing water entry at the cellar door area, and implementing additional waterproofing or drainage measures as needed. Failure to address these conditions may result in continued water intrusion, material deterioration, and additional moisture-related concerns.

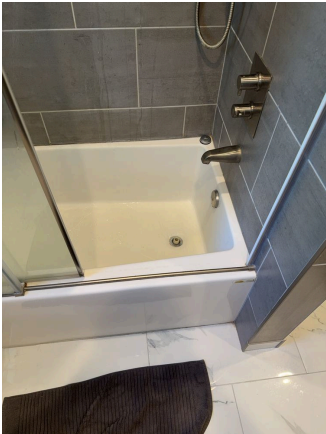
Location: 2nd Floor Bathroom Tub

Hindered (slow) drainage was observed in one or more referenced fixture(s) at the time of inspection. This condition may result from partial blockages due to debris, buildup within the drain line, improper venting, or inadequate pipe slope. Slow drainage can lead to standing water, unpleasant odors, and reduced fixture performance. The inspector recommends evaluating the affected drain(s), clearing any obstructions, and verifying proper venting and slope. Failure to address this condition may result in continued drainage issues, potential backups, and damage to plumbing components or finishes.

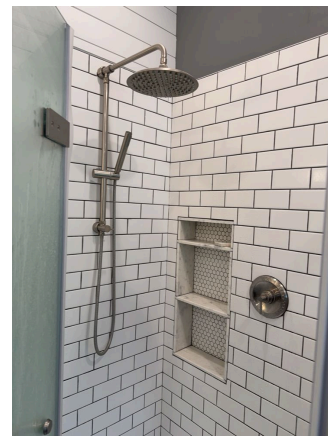
**Location:** Showers

One or more referenced fixture(s) were observed to produce lukewarm water rather than hot water. This condition may be related to the hot water delivery system, such as water heater temperature settings, a mixing valve adjustment, distribution limitations, or fixture-specific anti-scald devices. **It is common for newer fixtures and mixing valves to be set conservatively to help prevent scalding, which can result in lower delivered temperatures at the tap.** While this may be intentional, the water temperature did not meet typical expectations for hot water during normal operation. The inspector recommends evaluating the hot water system and associated mixing components and making adjustments or repairs, as needed, to achieve consistent and appropriate hot water delivery. Failure to address this condition may result in continued inadequate hot water and reduced functionality of plumbing fixtures.

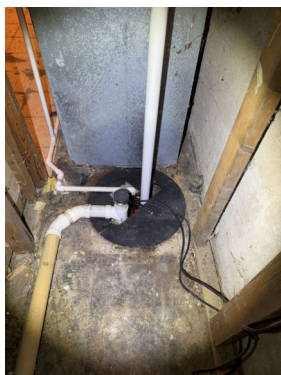
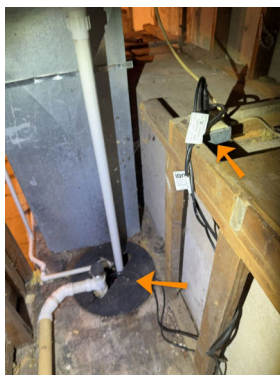
**Location:** Basement

The sump pump lacked a backup system and was connected to a GFCI-protected circuit. While GFCI protection may be permitted under current standards in certain installations, nuisance tripping can disable the sump pump and increase the risk of basement flooding without the homeowner's knowledge. The absence of a backup system also leaves the home vulnerable to water intrusion during power outages or primary pump failure. The inspector recommends installing a battery backup sump pump system and consulting with an electrician regarding the GFCI-protected circuit configuration. Failure to address these conditions may result in water intrusion, property damage, and conditions conducive to presumed microbial growth.

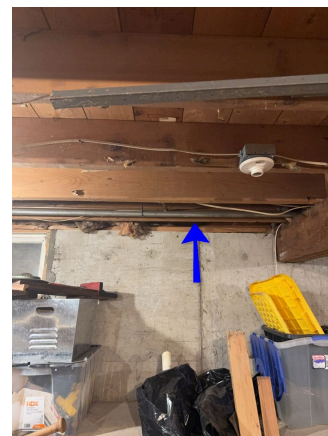
**Location:** Basement

The gas distribution system in the referenced area(s) was observed to have some galvanized pipes, which may pose a safety concern due to their age and susceptibility to corrosion. Galvanized pipes, often used in older homes, can corrode over time, potentially leading to gas leaks or reduced flow, especially if not replaced during system updates, as they are less durable than modern alternatives like black steel. The inspector recommends evaluating the gas distribution system and making necessary adjustments, such as replacing the galvanized pipes with modern, corrosion-resistant materials like black steel to enhance safety and reliability. If this issue isn't addressed, it may lead to gas leaks, fire hazards, or the need for more frequent maintenance over time.

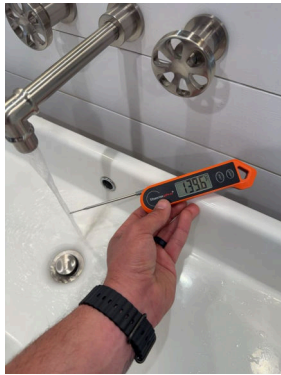
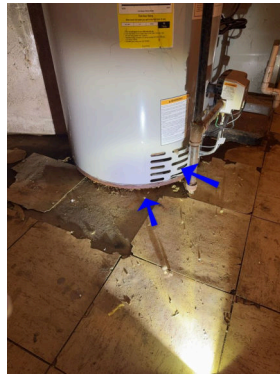
### 15.1.9 Water Heater- Over 130 Degrees And Deterioration

The water heater was producing water temperatures in excess of 130°F, and the tank exhibited rust, corrosion, and general deterioration. Water temperatures above the commonly recommended 120°F setting can increase the risk of scalding injuries and unnecessary energy consumption, while corrosion and deterioration of the tank may indicate advanced wear and an increased likelihood of leakage or premature failure. Failure to address these conditions may result in personal injury, water damage, and unexpected loss of hot water service. The inspector recommends adjusting the water heater temperature to a safer setting and further evaluating the condition of the tank to determine whether repair or replacement is warranted based on its overall condition and remaining service life.

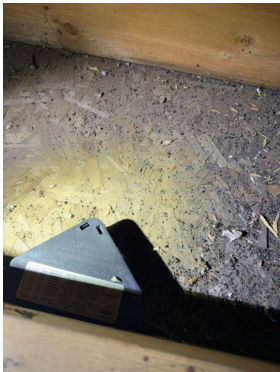
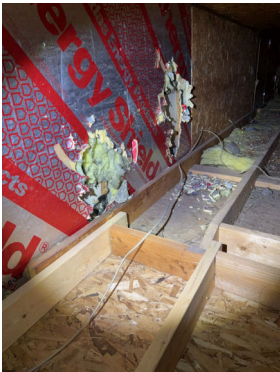
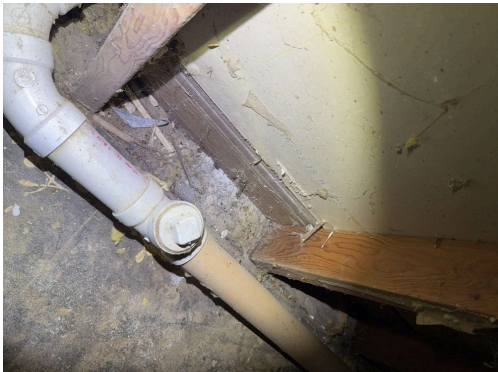
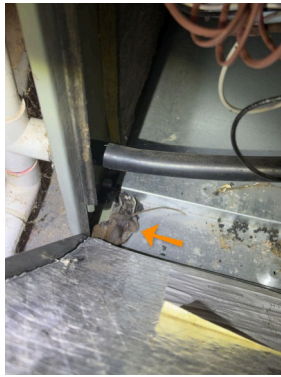
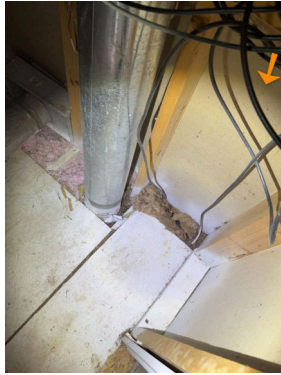
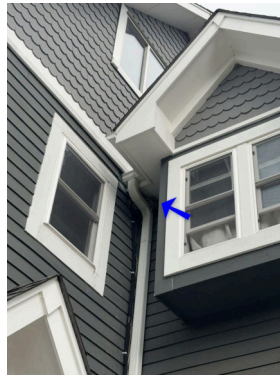
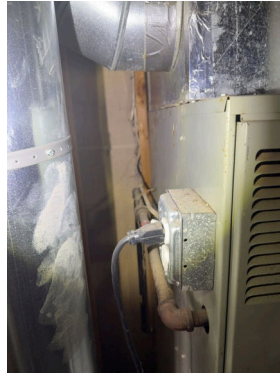
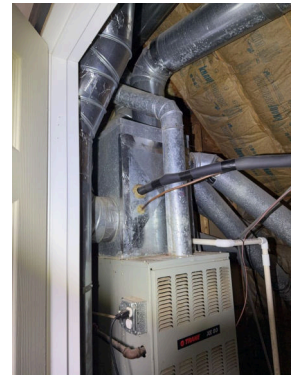
**Location:** Porch Attic, Basement, Basement Furnace, Back Of Home, Attic

Suspected active pest activity was noted in the attic at the time of inspection, which limited the ability to fully inspect that area. As a result, additional concealed conditions may be present that were not visible during the inspection. The inspector recommends further evaluation by a pest control professional, sealing potential entry points, and removing and replacing any insulation or materials damaged or contaminated by pest activity as needed. Failure to address these conditions may result in continued infestation, property damage, contamination, and additional concealed defects.

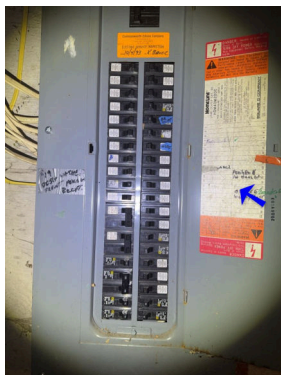
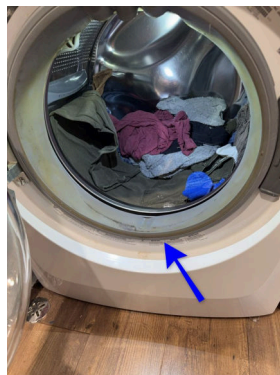
Presumed microbial growth was observed within the electrical panel and at one or more washing machine door seals. An odor was also noted at the washing machine, which is commonly associated with trapped moisture and buildup within the appliance. Failure to address these conditions may allow continued microbial growth and moisture-related deterioration. The inspector recommends correcting any moisture intrusion concerns at the electrical panel and cleaning the affected washing machine seals and components as part of routine maintenance.

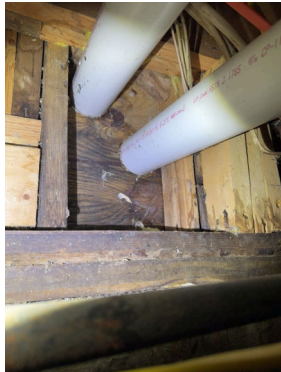
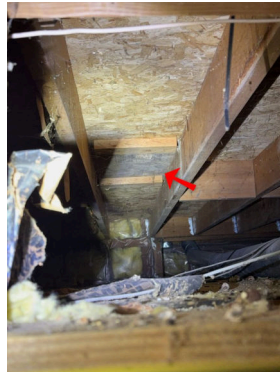
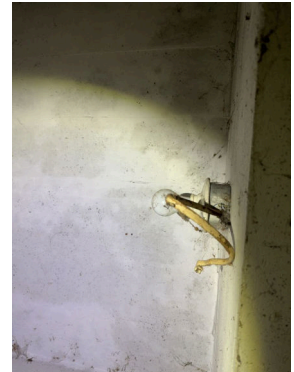
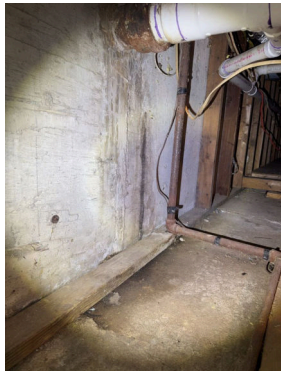
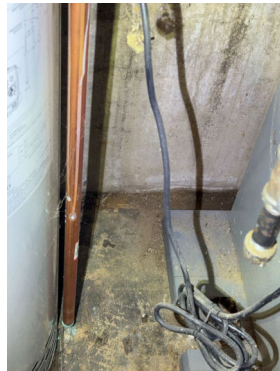
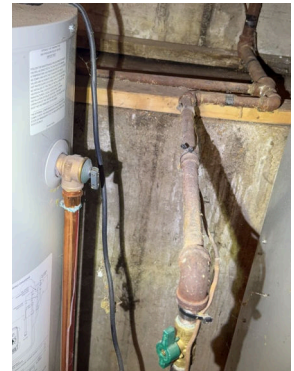
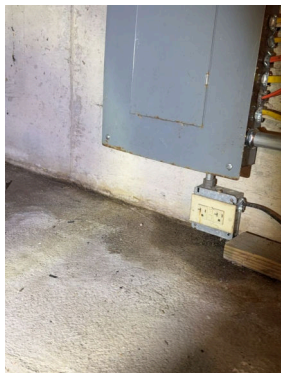
**Location:** Basement - Back Of Home, Crawlspace- Back of Home, Basement

### 17.2.3 Referenced Areas-Presumed Mold Growth

The inspector recommends identifying and correcting any active sources of moisture intrusion, including areas of water seepage, and further evaluating the affected materials to determine the extent of contamination and any necessary remediation. Failure to address the underlying moisture conditions may result in continued microbial growth, material deterioration, and additional concealed damage.

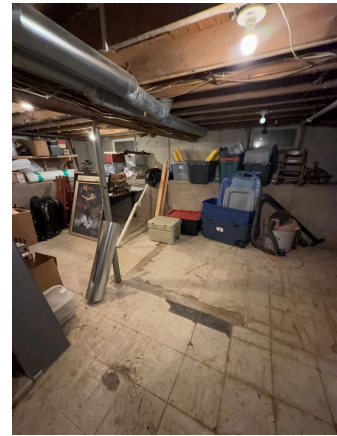
**Location:** Basement

A musty smell was detected in the referenced area(s) during the inspection. This type of odor is often associated with elevated humidity, poor ventilation, or the presence of mold, mildew, or moisture intrusion. While no visible microbial growth may have been present at the time of inspection, the odor indicates the potential for concealed moisture or microbial activity. The inspector recommends evaluating the area for sources of moisture, improving ventilation, and conducting further investigation if the odor persists. Failure to address the underlying cause may result in continued odor issues, poor indoor air quality, and potential damage to building materials.
