At Ease Inspections

## HOME INSPECTION REPORT

123 Sample Street, Demo City, ST 12345

6/18/2026 5:21AM

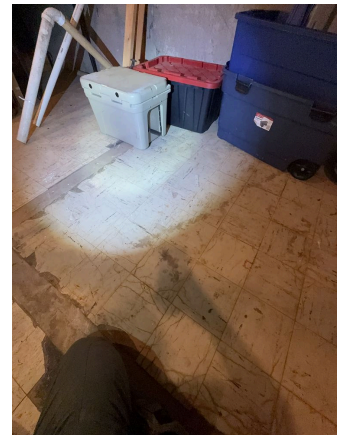
**Location:** Basement

One or more flooring tile(s) in the referenced area(s) appeared to be presumed asbestos-containing materials based on the age, appearance, and characteristics of the materials observed. Asbestos-containing floor tiles were commonly used in older homes and buildings. Intact materials that are in good condition are generally considered less likely to release fibers; however, disturbance, damage, deterioration, or renovation activities may increase the potential for asbestos fiber release. Identification of asbestos-containing materials requires laboratory testing and is beyond the scope of a standard home inspection. The inspector recommends avoiding disturbance of the materials and consulting with an environmental specialist if testing, renovation, removal, or further evaluation is desired. Failure to properly manage or handle asbestos-containing materials may result in potential health and environmental concerns.

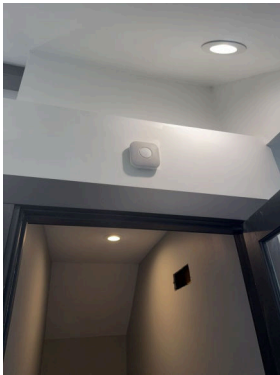
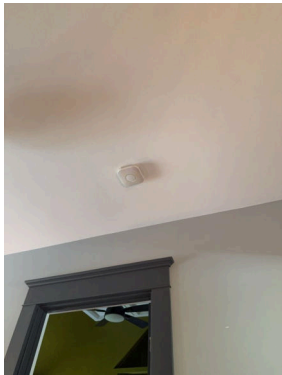
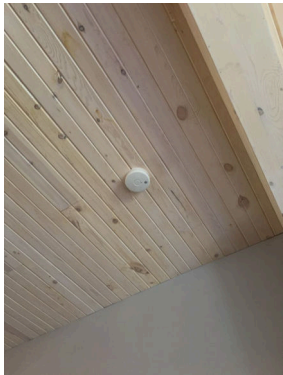
#### 18.1.1 Smoke Detector Locations- PICTURES: 1st floor, 2nd floor, 3rd floor

Please follow the illustrations below on proper placement for carbon monoxide, smoke detectors and fire extinguishers. At Ease Inspections recommends replacing all smoke detectors in the home regardless of age with the recently mandated 10 year smoke/CO detectors. If you ever have any questions or concerns, please contact us immediately/CO detector placement is important and we want you to be safe!

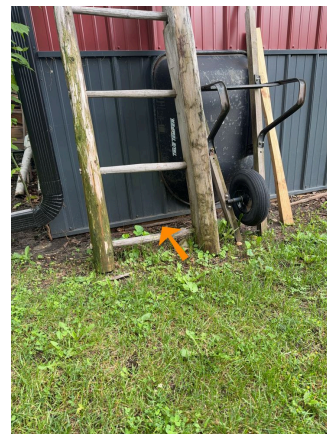
**Location:** Garage - All Sides

One or more wood components were observed in contact with soil or organic material in the referenced area(s). This condition can promote moisture absorption, wood decay, and insect activity, which may lead to deterioration of the affected materials over time. Correction is recommended to separate wood from soil and organic debris and to address any damaged areas as needed to help reduce the risk of further deterioration.

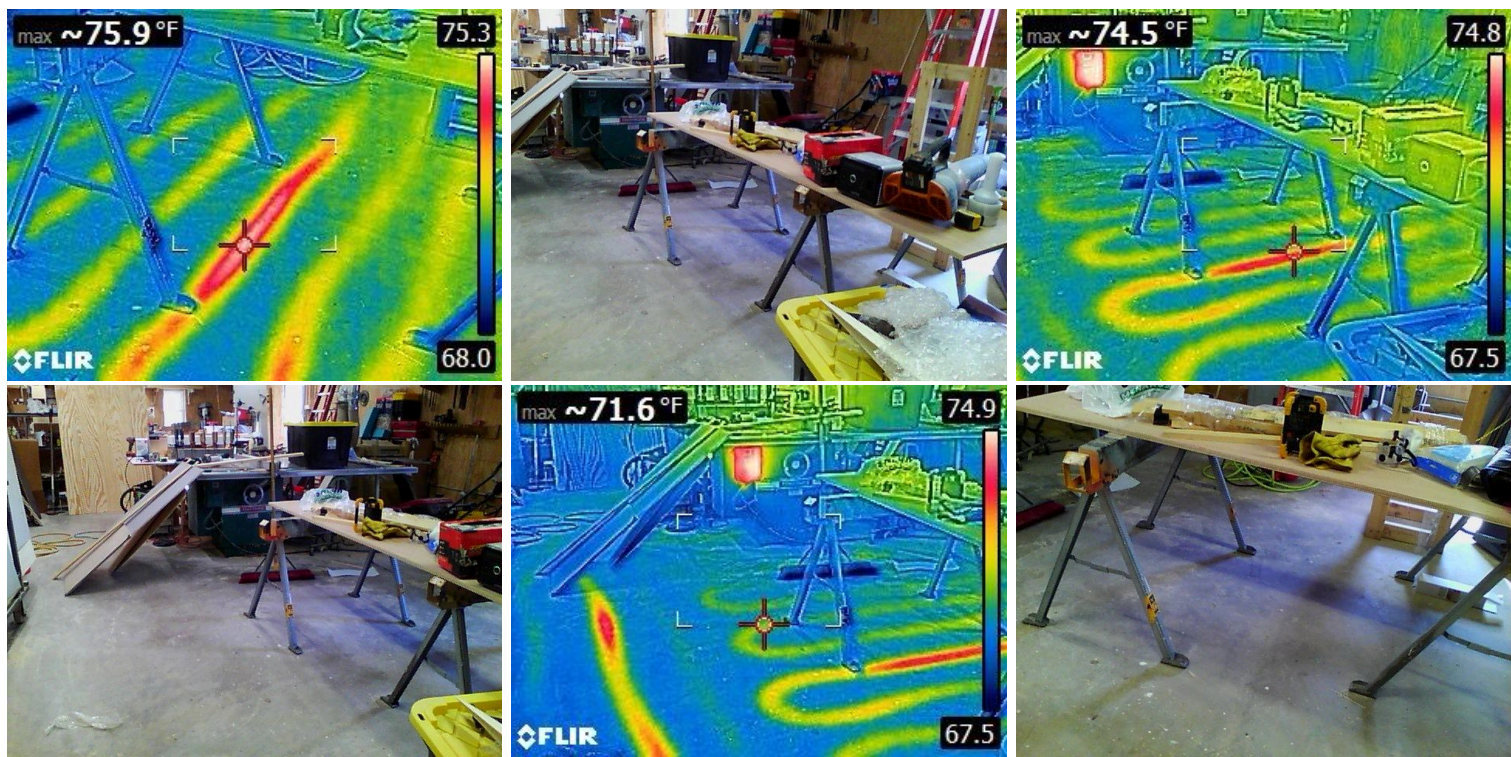
#### 21.1.2 Thermal Imaging Pictures

*Thermal imaging was performed throughout accessible areas of the home. Only areas exhibiting thermal irregularities or conditions of concern are included in this report. No significant anomalies were observed in other scanned areas at the time of inspection.*
